STATUS UPDATE ON FEMA ACCREDITATION OF RIO GRANDE FLOOD CONTROL LEVEES

**International Boundary and Water Commission
United States Section**

INSTALLATION OF SOUND INSULATION PANELS AT COUNTRY CLUB BRIDGE FLOODGATES

February 12, 2015

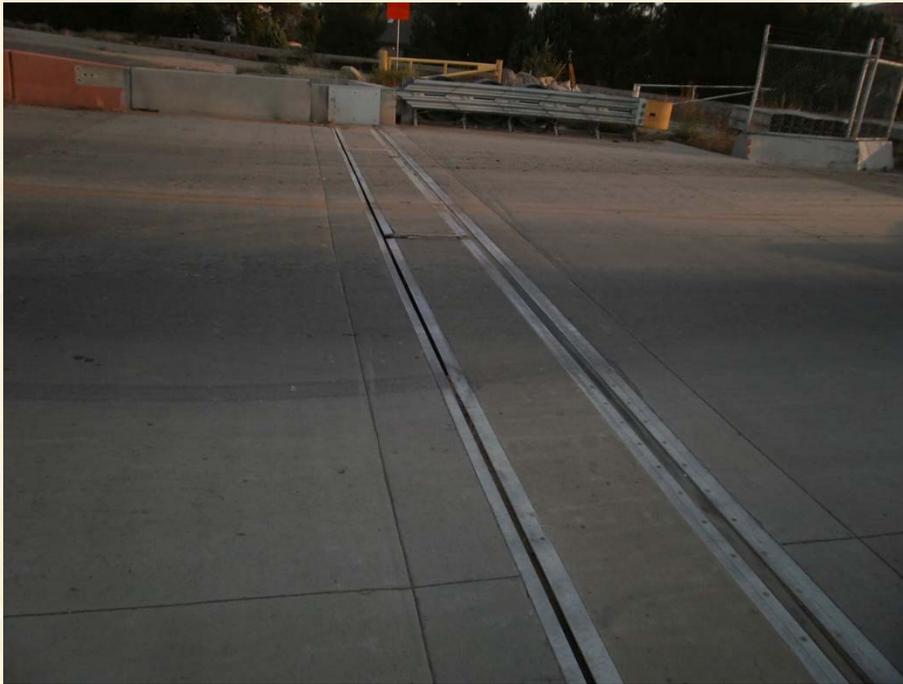
Facing North

Floodgate Structure Prior to Opening

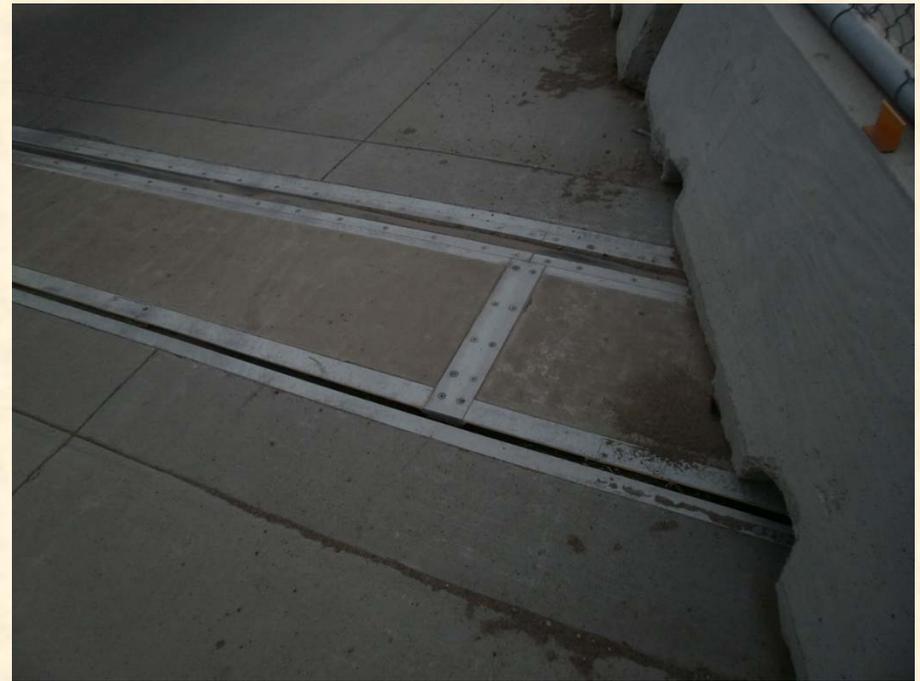
**South End of Structure
Jersey Barrier Set on Top**

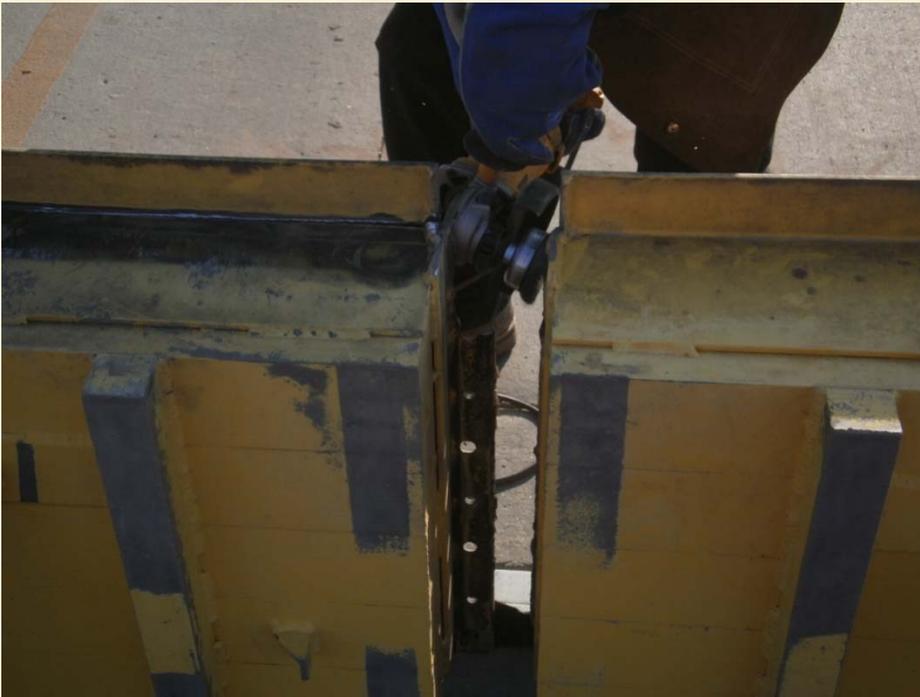
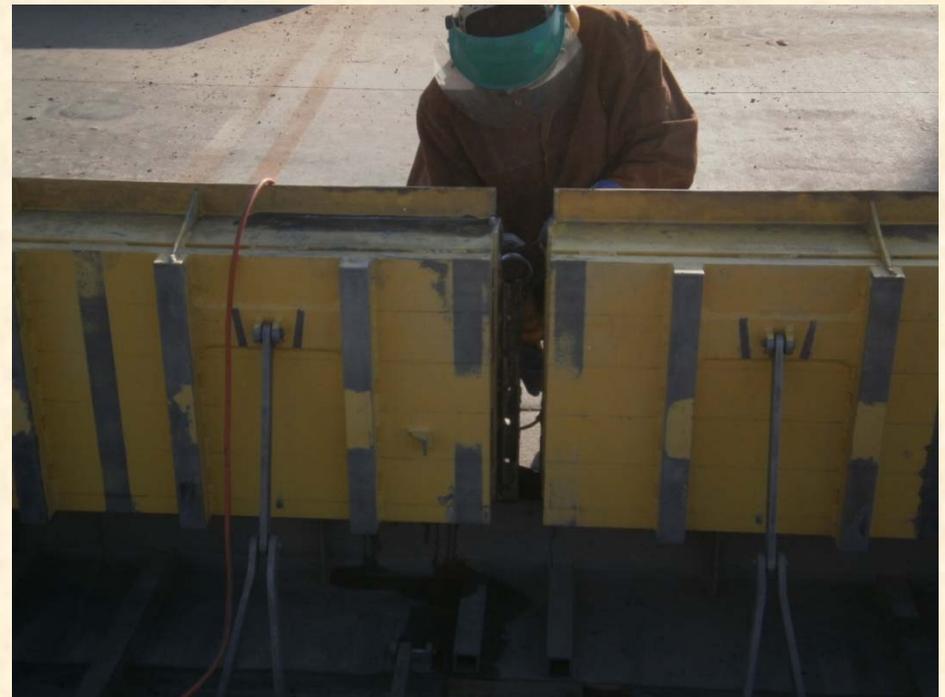
Impact Areas Inside of Structure that Makes Contact Caused by Traffic

**Impact Areas of Structure. Discolored Areas Where Top
Plate Contacts Bottom Plate**

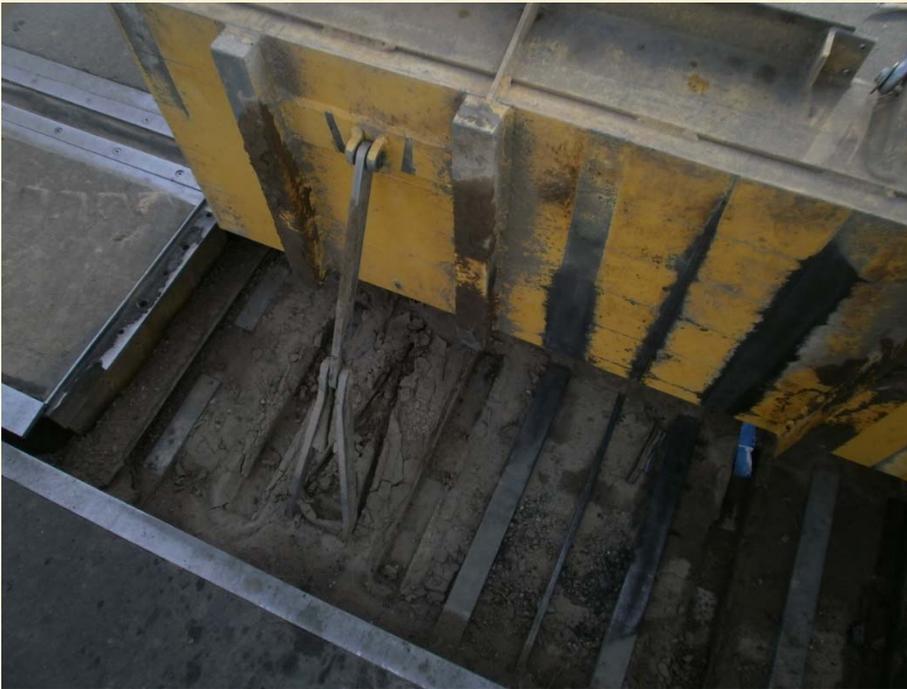
Right Section

Conditions Inside of Structure
