APPENDIX K

CONTROLLING WATER ON THE BORDER:
THE AMERICAN CANAL SYSTEM,
INTERNATIONAL BOUNDARY AND WATER COMMISSION,
EL PASO, TEXAS

Prepared for
United States Section
International Boundary and Water Commission
United States and Mexico
El Paso, Texas
Contract #IBM 96-23

November 1999
HSR Report No. 9904

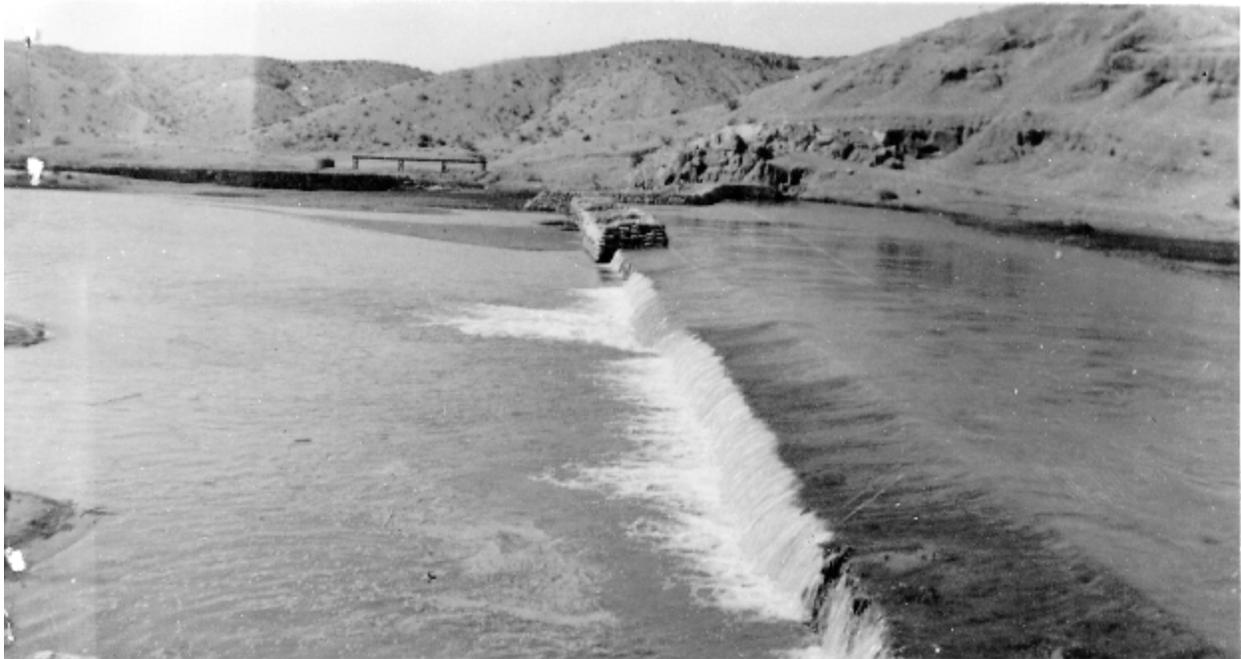
Plate 2. Mexican Dam and Head of Juarez's Acequia Madre
(August 1934 - NARA, BOR, RG 115-87-0028, Resch report).

The reason the Franklin Canal was of little concern to Mexican water users can be traced to the location of the dam that supplied water to the canal. The Mexican Dam appears to have been rebuilt in 1848 and then again between 1886 and 1889 using stronger materials (Plate 2). At the same time, the American Dam was constructed 1800 ft *below* the Mexican Dam. Although efforts were made to place the American Dam upstream of the Mexican Dam, opposition from American landowners prevented its construction at that location. Consequently, farmers on the Acequia Madre in Juarez were able to divert water before it reached the American Dam and the Franklin Canal did not pose any substantial threat to Mexican farmers (BOR, NARA, RG 115, Project Reports, Fiock letter, 22 July 1935). Sometime between 1904 and 1909, the intake or throat of the Franklin Canal was relocated to a point some 150 to 200 ft above the Mexican Dam (BOR, NARA, RG 115, Project Reports, pg. 14; Fiock, BOR, FRC, 22 July 1935). The apparent lack of response of the Mexican government to this relocation suggests this intake was constructed after the 1906 agreement in which the United States agreed to supply Mexico with water (see Appendix AA for a copy of this treaty).

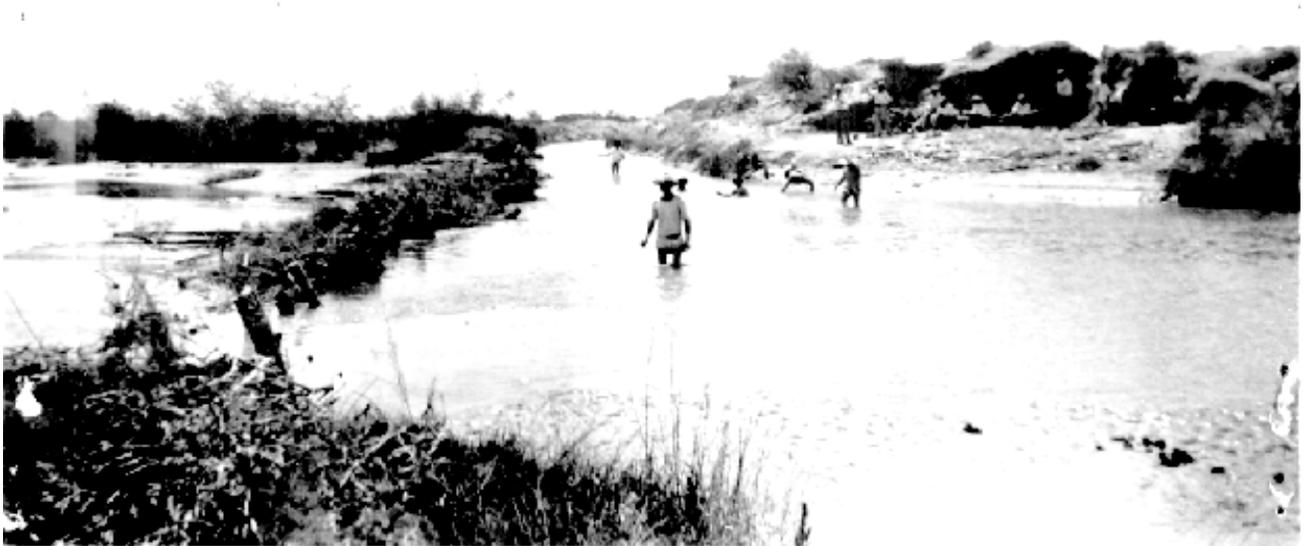
Plate 3. Brush-and-Rock Diversion Dam of the San Augustine Acequia
(August 1934 - NARA, BOR, RG 115-87-0028, Resch Report).

The apparent locations of these illegal diversion dams began with the San Augustine Acequia (Plate 3) some 17 mi below the International Dam (BOR, RG 115, NARA, General Correspondence files, 1902–194, Fiock 1935:np; BOR, RG 115, NARA, General Correspondence files, 1902–1942, Box 1109, 115-54-A-81, Folder 249, pg. 4). Still other illegal diversion dams were found further downstream (Lawson 1926:4). These included, ordered by downstream distance, the Guadalupe Acequia (32 mi), San Ignacio Acequia (32 mi—Plate 4), Porvenir Acequias (44 and 45 mi—Plate 5 below), Miramar Acequia (48 mi), Cuervo Acequia (Plate 6), and San Lorenzo Acequia (Plate 7).

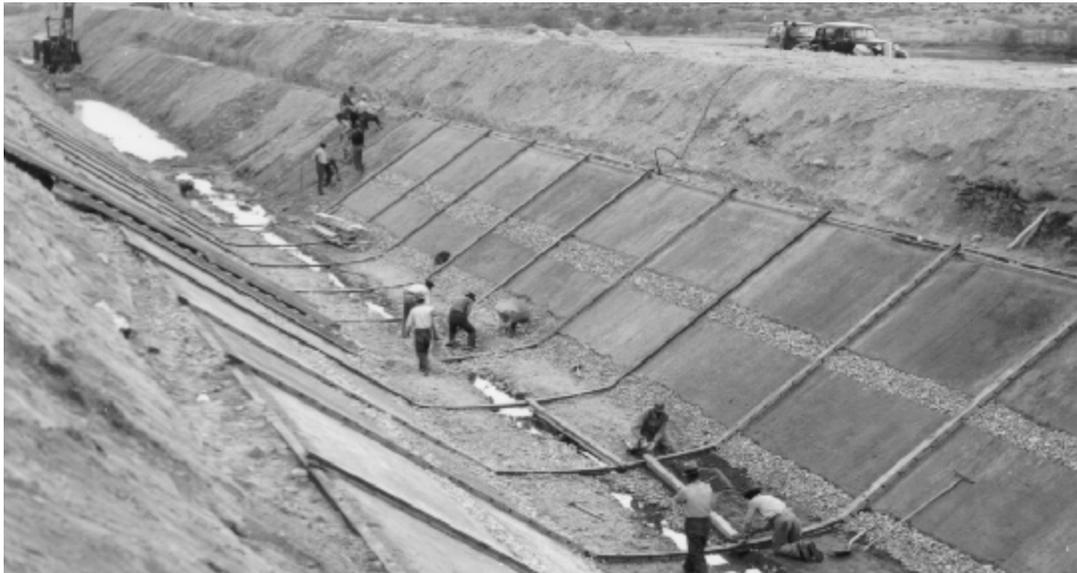
Plate 9. Open Section "A" Showing Configuration of Construction Joints and Gravel Drains Common in All Open Sections, 31 December 1937.

There are a number of attributes common to all of the American Canal's open sections. Concrete lining in open sections contain vertical construction joints across the bottom and side slopes on 10-ft centers. The lining also includes 2-in.-diameter weep holes draining into 1 x 1 ft gravel drains located along 5-foot centers. There are five weep holes per cross-section, two on each side and one on the bottom (Plate 9).

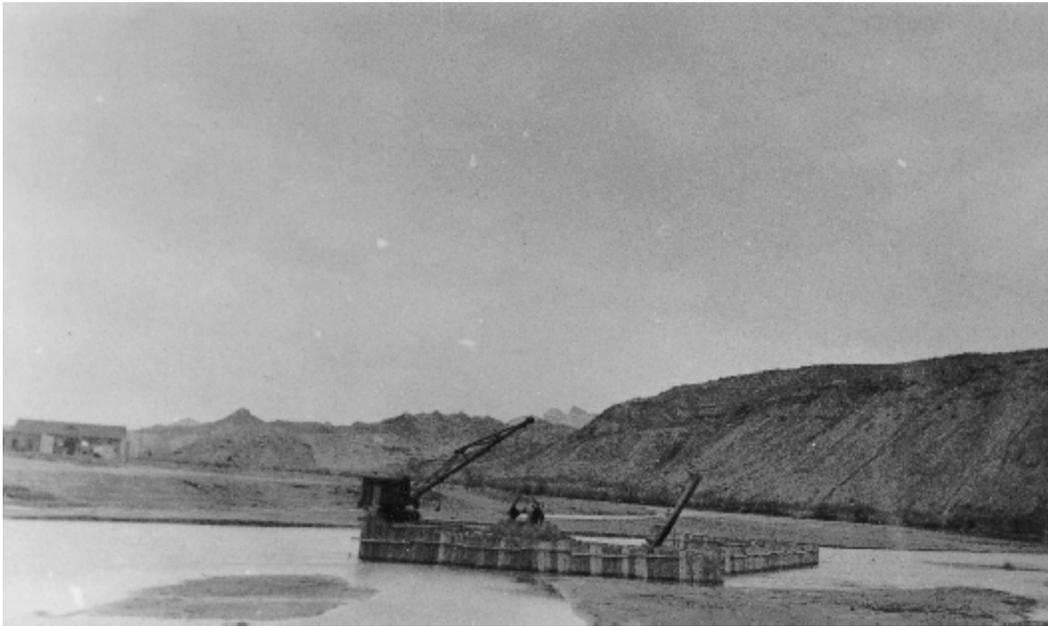
Plate 11. Cofferdam for the American Dam, 8 February 1937.

- February 12, 1937 Canal Excavation started.
- February 15, 1937 Cofferdam for Units 2 and 3 completed; excavation for dam started; dewatering cofferdam started.
- February 27, 1937 Started driving steel sheet piling.

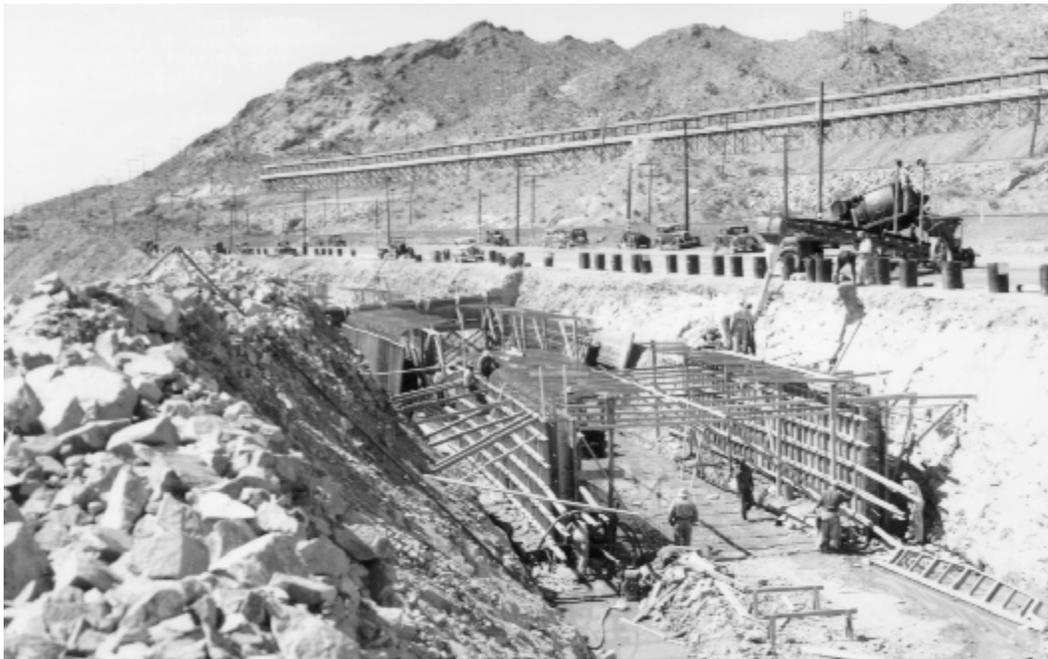
Plate 22. Pouring First Concrete, Closed Conduit "B," 22 June 1937.

June 11, 1937 First concrete poured for canal, at station 81+25, closed conduit "A."

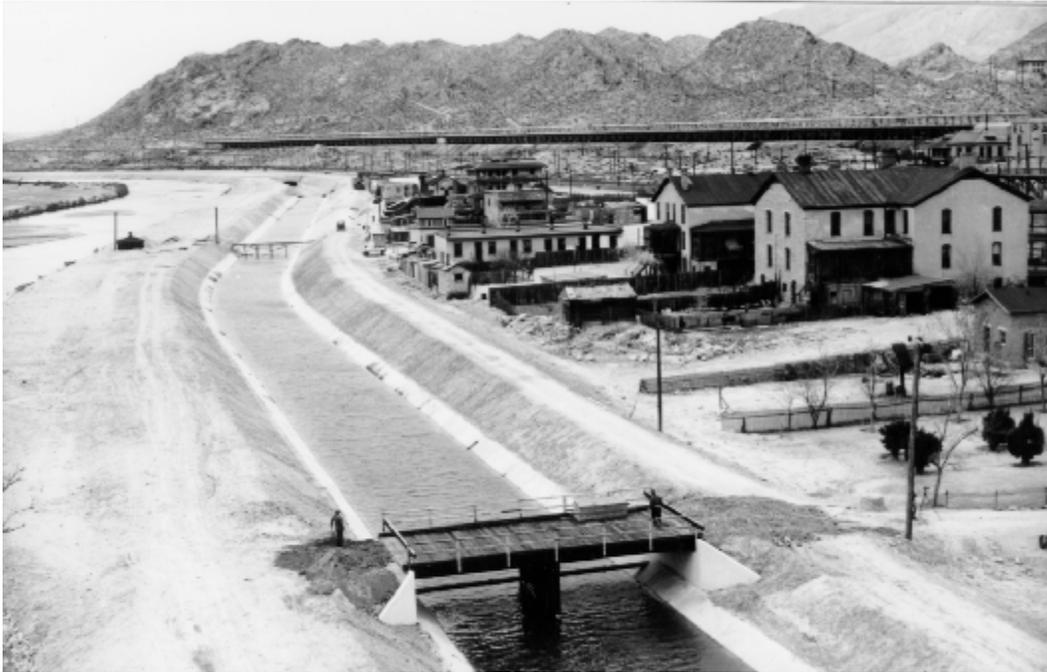
Plate 30. Lower Open Section "A" with Globe Street Bridge in Foreground, 12 March 1938.

- Plate 30: Photograph depicts 12 March 1938 view of Hart's Mill Road Bridge; and
- Plate 66: Photograph depicts 1999 view of the remnants of the Hart's Mill Road Bridge.

The descriptions of the Globe Street and Hart's Mill Road Bridges on pages 62, 66, and 67 of the HSR report contain incorrect information. The description and dimensions provided correctly describe only the Hart's Mill Road Bridge. A revised description of the two bridges can be summarized as follows:

An examination of USIBWC construction drawings, maps, and photographs reveals that while the Globe Street Bridge was constructed as a footbridge across the canal, the structure at Hart's Mill Road was a timber vehicular bridge. Although remnants of the Globe Street Bridge no longer exist, the original Hart's Mill Road Bridge has been replaced with a sewer line and only the abutments remain. Photograph #ADC-385 in the USIBWC archives depicts the construction of the Globe Street footbridge in an April 1938 view. Furthermore, a construction drawing dated May 28, 1938, and entitled "Earthwork & Gravel Surfacing at American Dam and Canal – General Plan" (#2693-49) corroborates the location and method of construction of both the Globe Street and Hart's Mill Road Bridges. No construction drawings have been found for the Globe Street pedestrian bridge, perhaps indicating the structure's simplicity of design.

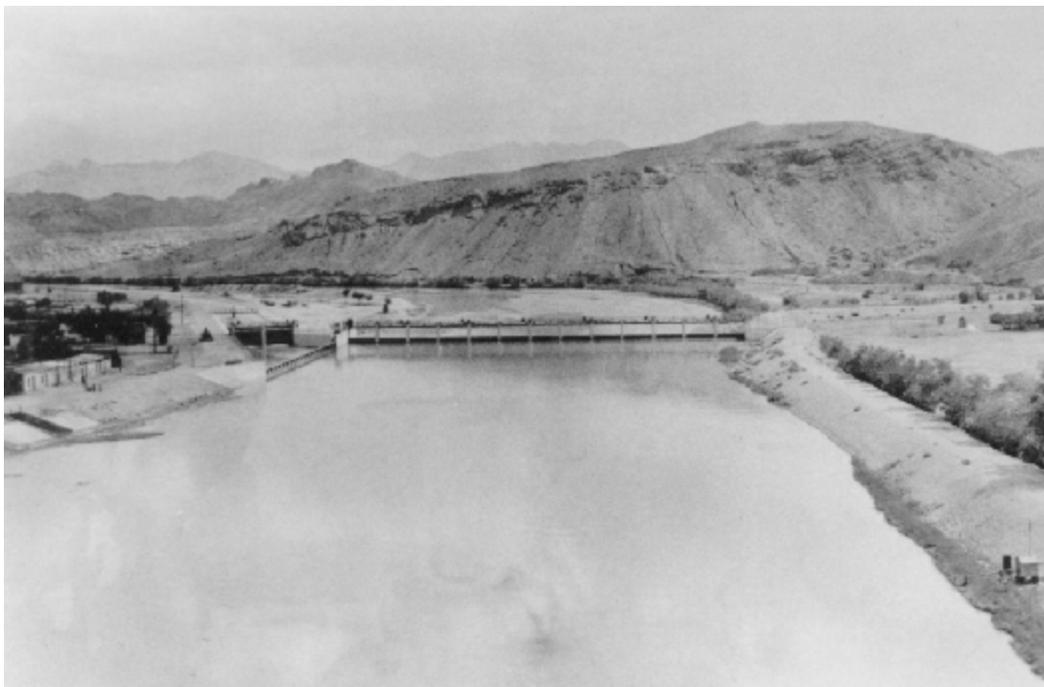
Plate 40. American Dam (center) and Canal (left), 1 July 1938.

As noted above, the dam has not been modified since its completion in 1938. It is 284 ft wide between abutments and 70 ft long from the edge of the upstream apron to the downstream side of the dentated-type sill. Water diversions are controlled by thirteen 7.56 x 20-ft radial gates, whose base is approximately 2 ft below the grade of the river bed.

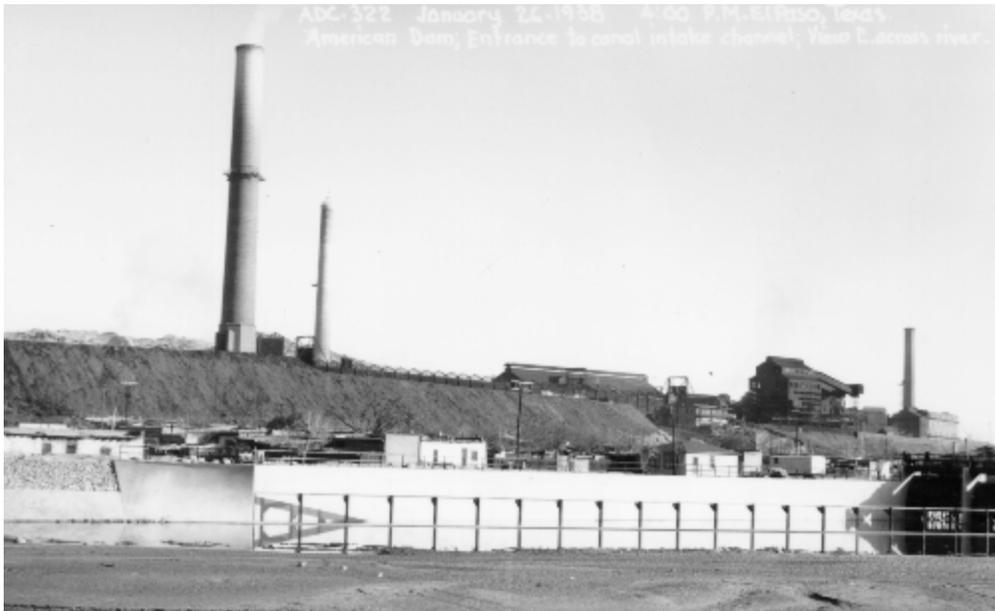
Plate 42. American Canal and Intake with Weir, 26 January 1938.

A comparison of photographs taken in 1938 and 1999 show that the intake and weir of the American Canal retains virtually all of its original, as-built characteristics (Plates 42 and 43). Indeed, there appears to have been no change to its configuration since 1938.

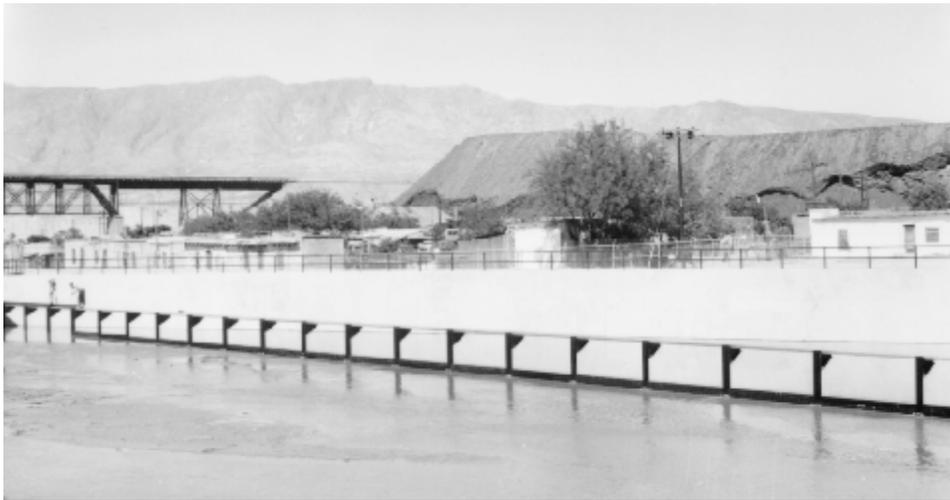
Plate 44. American Canal Weir Looking North, 14 May 1938

The original skimming weir, measuring 250 ft in length and 2 ft in height, is situated above the headgates of the canal (see Figure BB-3 in Appendix BB). Remeasurement during this inventory, as well as comparative repeat photography, confirmed that the contemporary weir conforms to the original design specifications (Plates 44 to 47). The hoist motors for each headgate are both 3 h.p. Gearmotor 1160-rpm designs (see Figure BB-4 in Appendix BB). These, too, also conform to original, as-built specifications (Plates 48 and 49). The dual 12 X 20 ft radial gates are of original construction (Plate 50, see Figure BB-2 in Appendix BB).

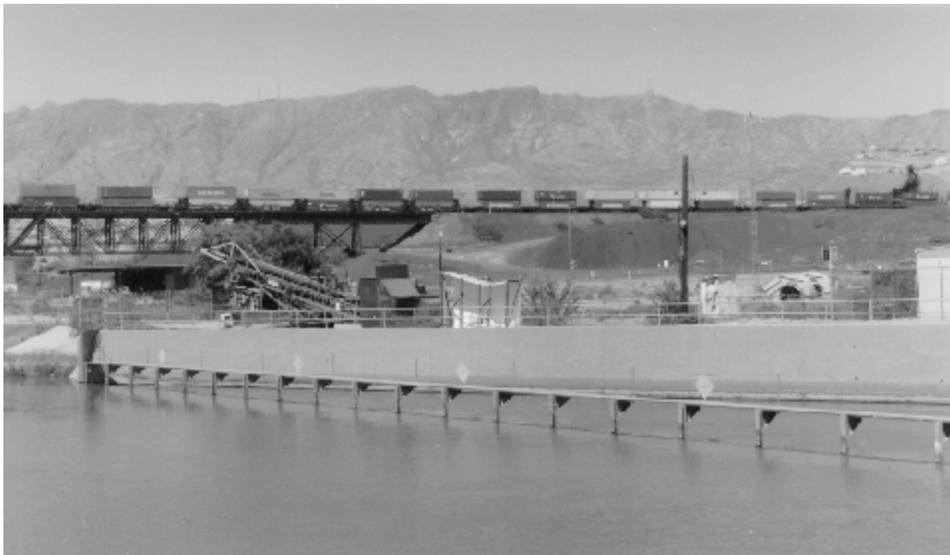
Plate 45. Repeat Photograph of American Canal Weir (1999).

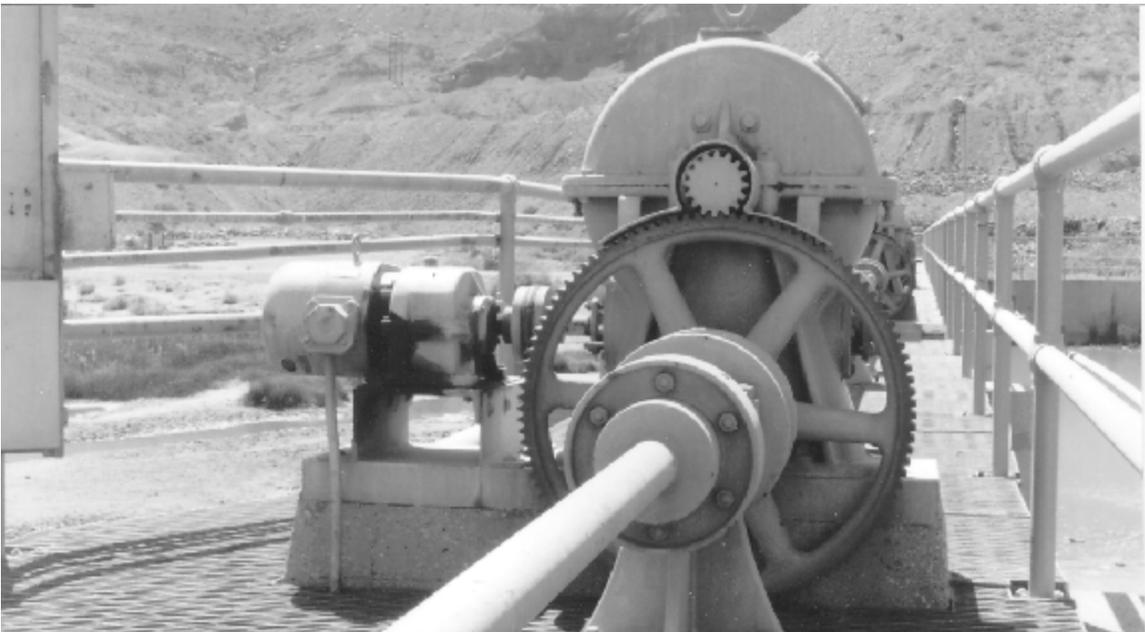
Plate 49. Repeat photograph of Hoist Machinery at the American Dam (1999).

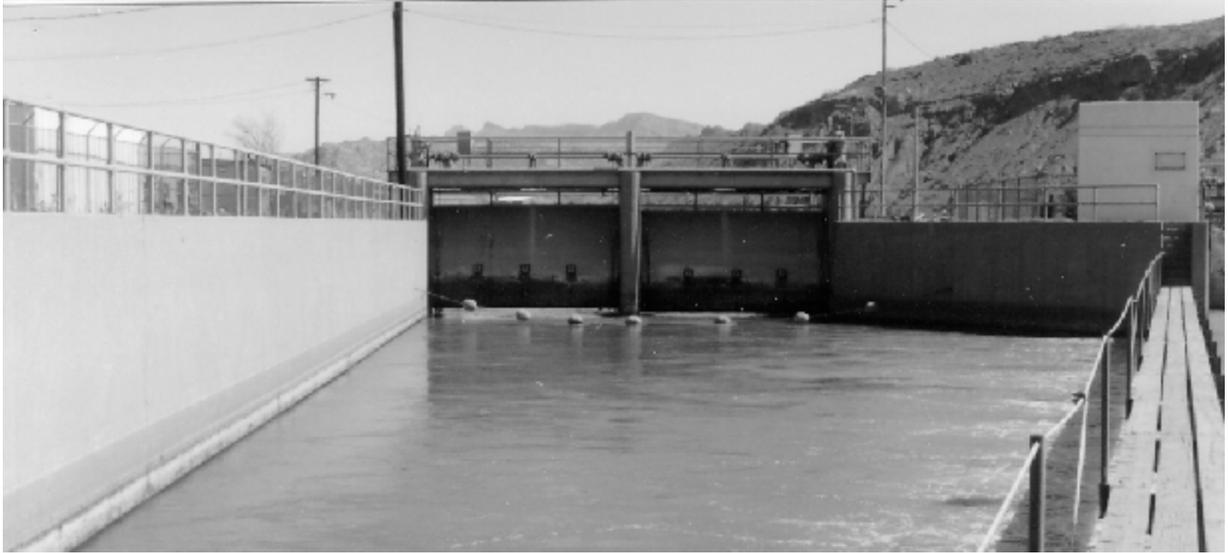
Plate 50. Upstream Intake of the American Canal Showing Radial Gates (1999).

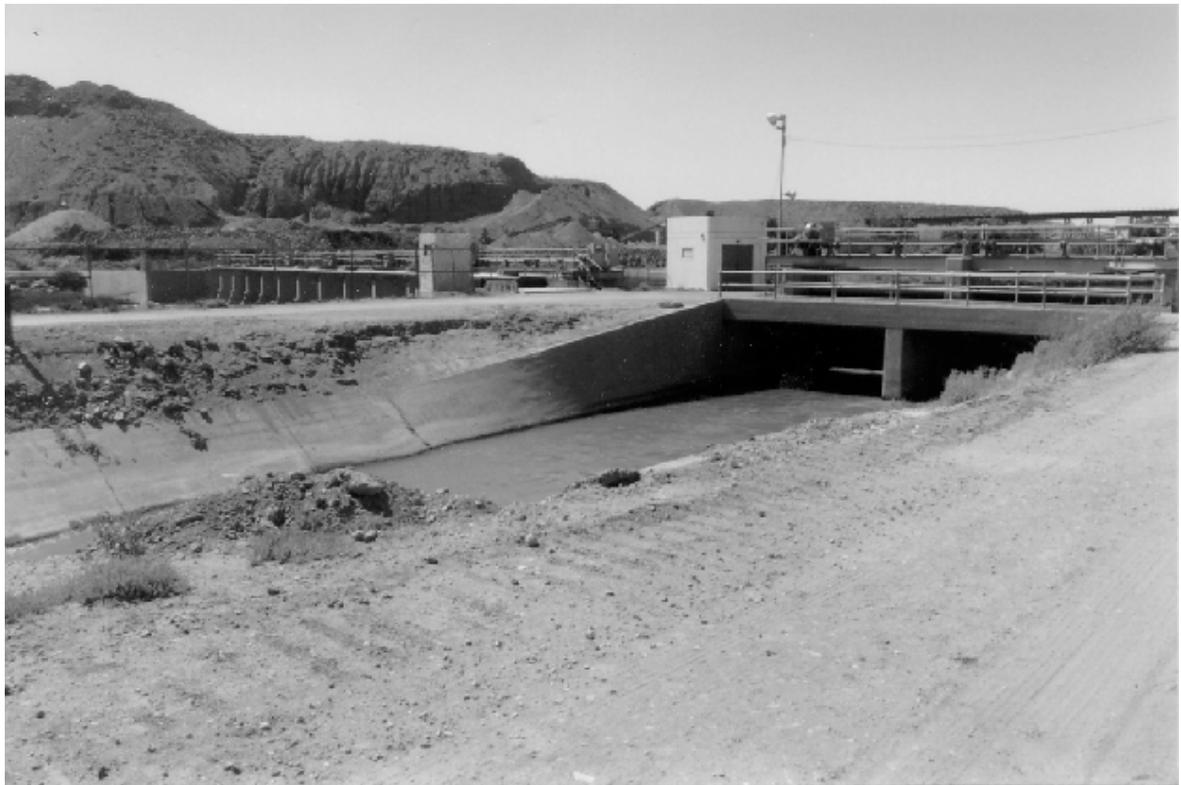
Plate 52. Repeat Photograph of the American Dam and Canal Intake (1999).

Examination of the contemporary American Canal also revealed a high degree of integrity with respect to original canal configurations. There is independent confirmation that the design attributes described above were largely implemented during final construction. Indeed, the contemporary canal corresponds almost precisely to an earlier summary by the Water and Power Resources Service (1981:1057) indicating that the canal is 2.1 mi long, concrete-lined, with side slopes at a 1.5:1 ratio, a bottom width of 12 ft, a water depth of 8.75 ft, and a capacity of 1,200 cfs. Further, the original headgate structure remains unchanged from that built in 1938 (Plates 51 and 52).

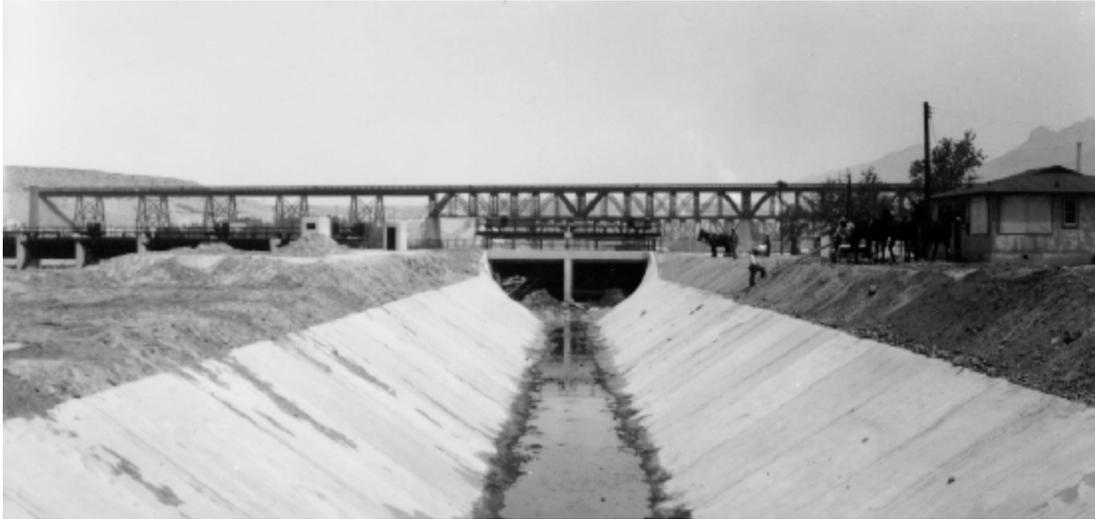
Plate 53. American Canal Downstream of Headgate, 30 April 1938.

The dimensions of the American Canal have remained largely unchanged since 1938. For example, Plates 53 and 54 present an original, as-built view of the American Canal downstream of the headgate and a repeat photograph taken in 1999.

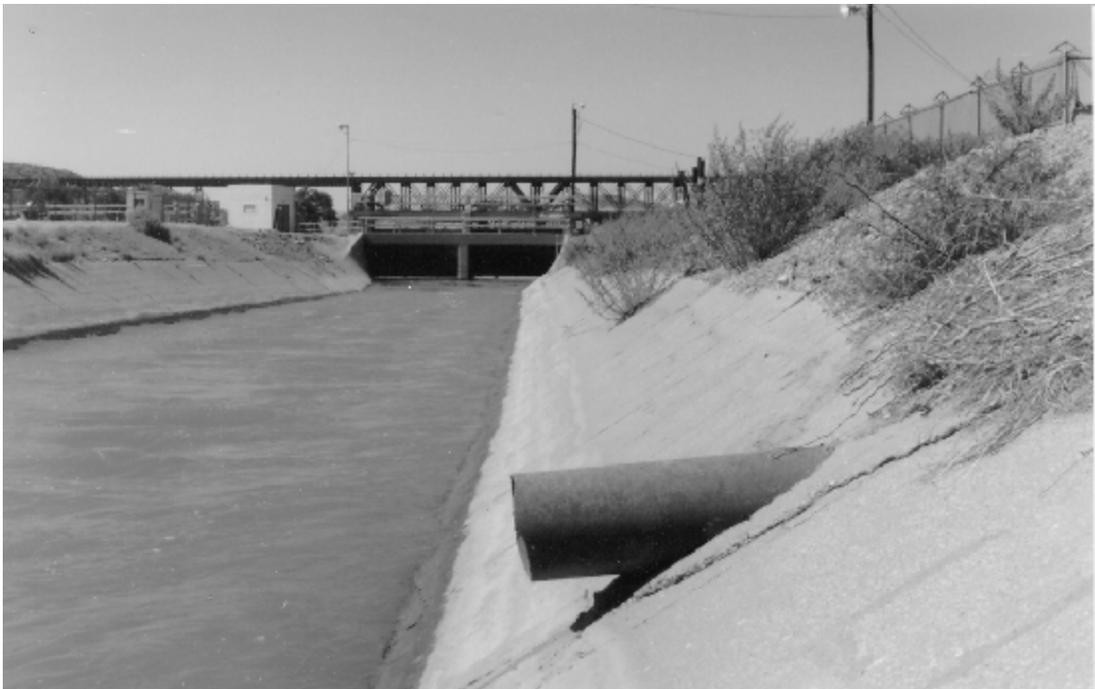
Plate 54. Repeat Photograph of American Canal Downstream of Headgate (1999).

Original, as-built dimensions of the American Canal are available from a series of cross-sections extending down the length of the canal (Table 1). Measurements during this inventory confirm that cross-sectional characteristics have remained unchanged since 1938, although several concrete “panels” have been replaced over time as required to maintain the canal in operational readiness. Original, as-built cross-sections of the American Canal are available from a number of sources. Open channel “A” cross-sections proved remarkably stable, as did the cross-sections of Open channel “B” portions of the canal (see Figure BB-5 and BB-6 in Appendix BB). For this study, canal widths were measured from the top of the concrete lining rather than the plane of the adjoining berms since successive remodeling probably has altered this plane. All 1938 measurements have been modified accordingly to match this measurement approach.

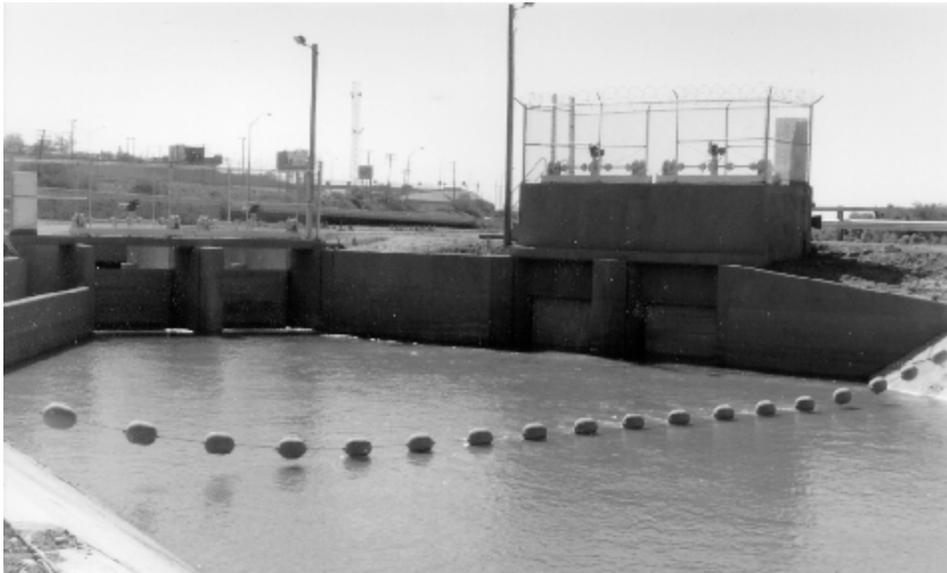
Plate 56. Headgates of the Franklin (left) and Wastegates (right) of the American Canals (1999).

In contrast, the confluence of the American Canal with the Franklin Canal has undergone significant modifications as a result of reconstruction in 1997 (Plates 55 and 56). Plate 55 shows a view looking upstream at the skimming weir and the settling basin. Plate 56 shows a view looking downstream from the downstream end of the reconstructed settling basin. As a consequence, there is little correspondence between the original configuration of the American-Franklin confluence in 1938 and that observed today.

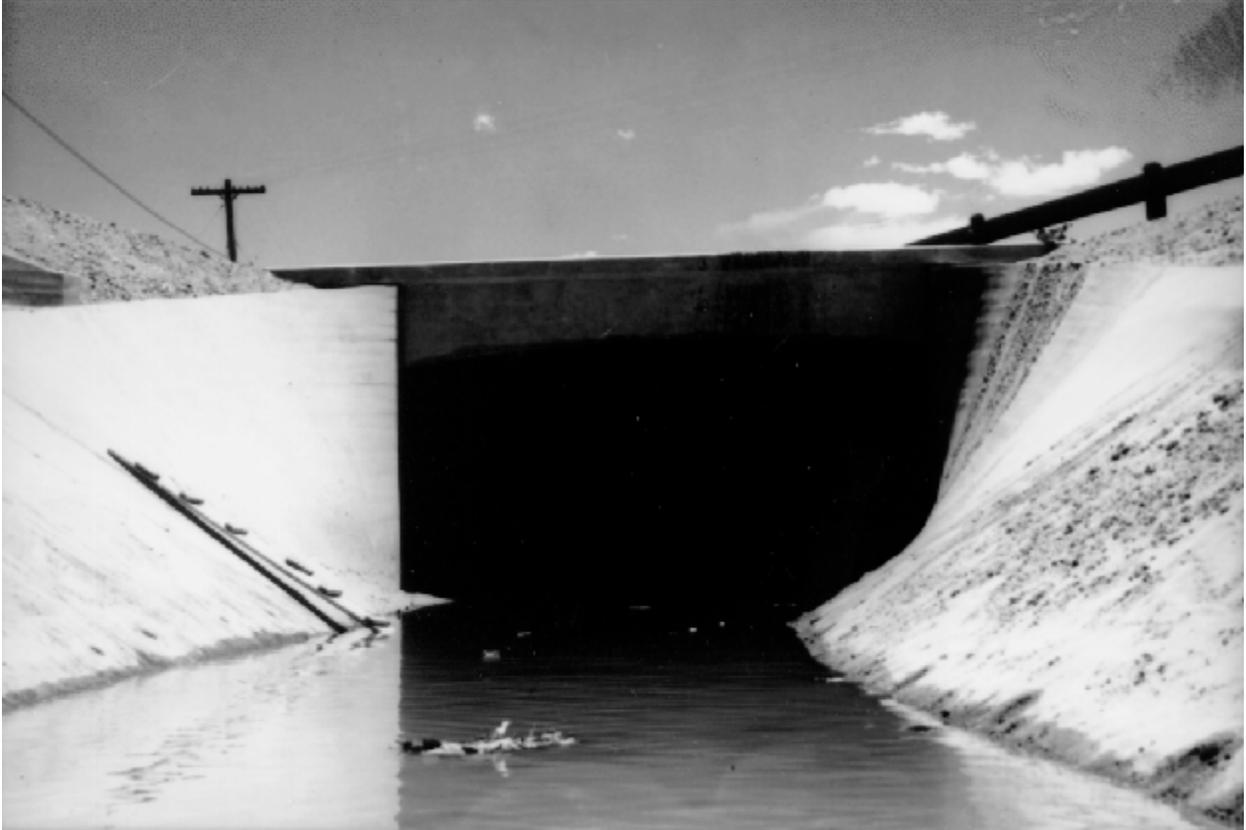
Plate 57. Upstream Intake of Closed Conduit “B,” 25 May 1938.

The two subterranean conduits, “A” and “B,” also show no discernable changes compared with their 1938, as-built characteristics (see Figure BB-7 in Appendix BB). Dimensions measured during this inventory, as well as comparative repeat photography, conform precisely to the 1938 nominal specifications (Plates 57 and 58).

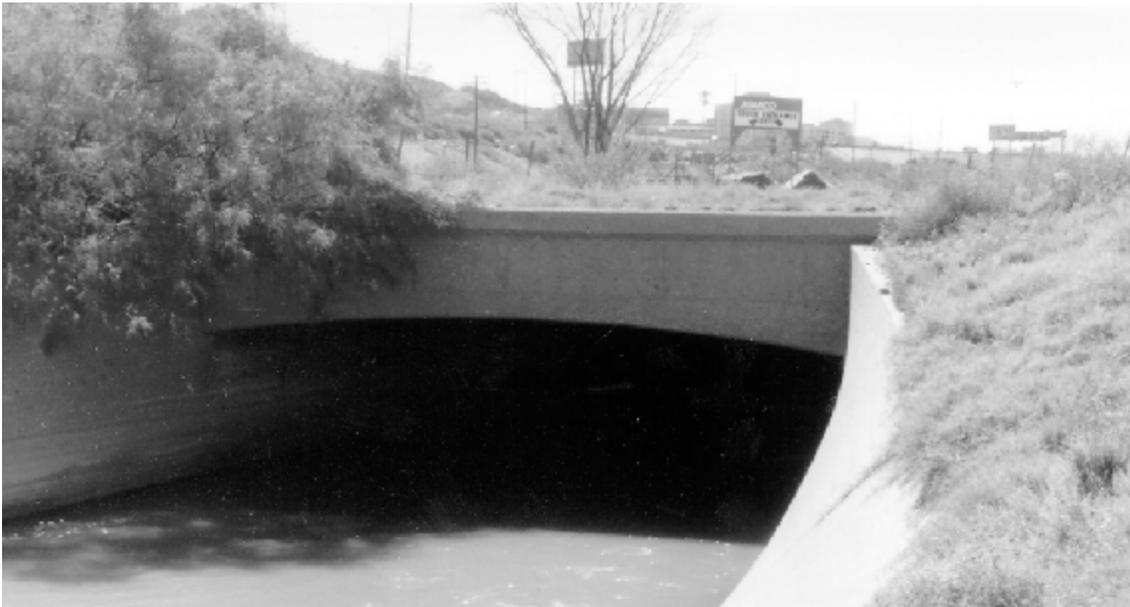
Plate 58. Repeat Photograph of Intake of Closed Conduit "B" (1999).

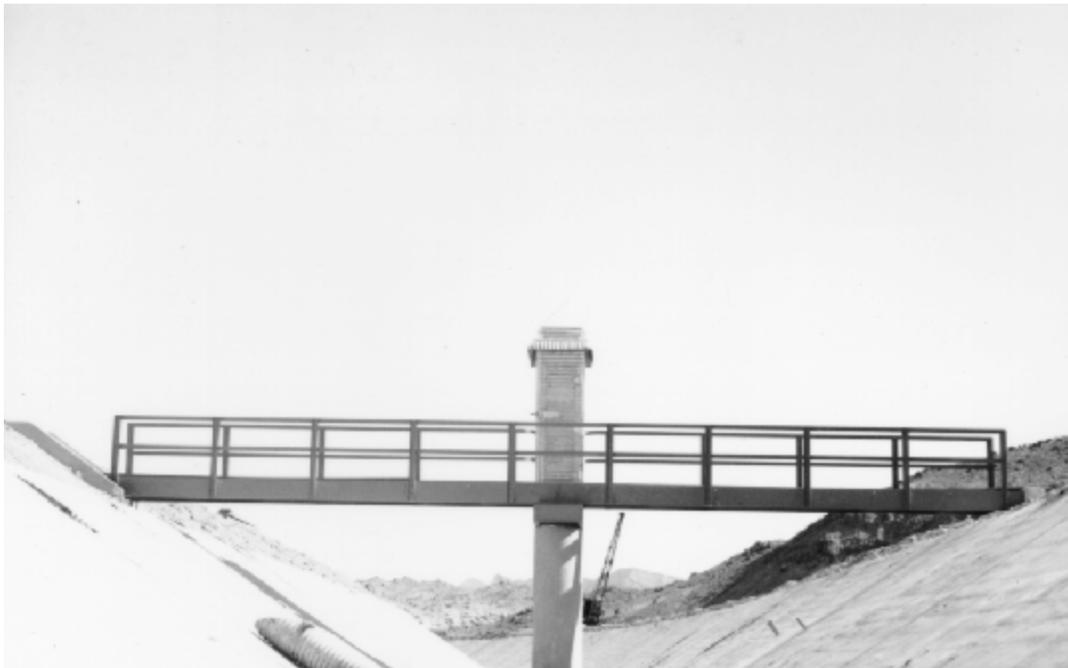
Plate 61. Detail of Gauging Station 100 m Downstream
of American Canal Headgates, 1 May 1938.

There is one gauge in the American Canal, one located about 100 m downstream from the headgate. (Plates 60 and 61). Original specifications for these devices could not be located. Regardless, the 1938 gauges have been replaced by three newer gauging devices. One is located about 110 m downstream from the headgate, another at the intake of Conduit "A," and the last approximately 150 m above the headgate of the Franklin Canal (Plates 62 to 64).

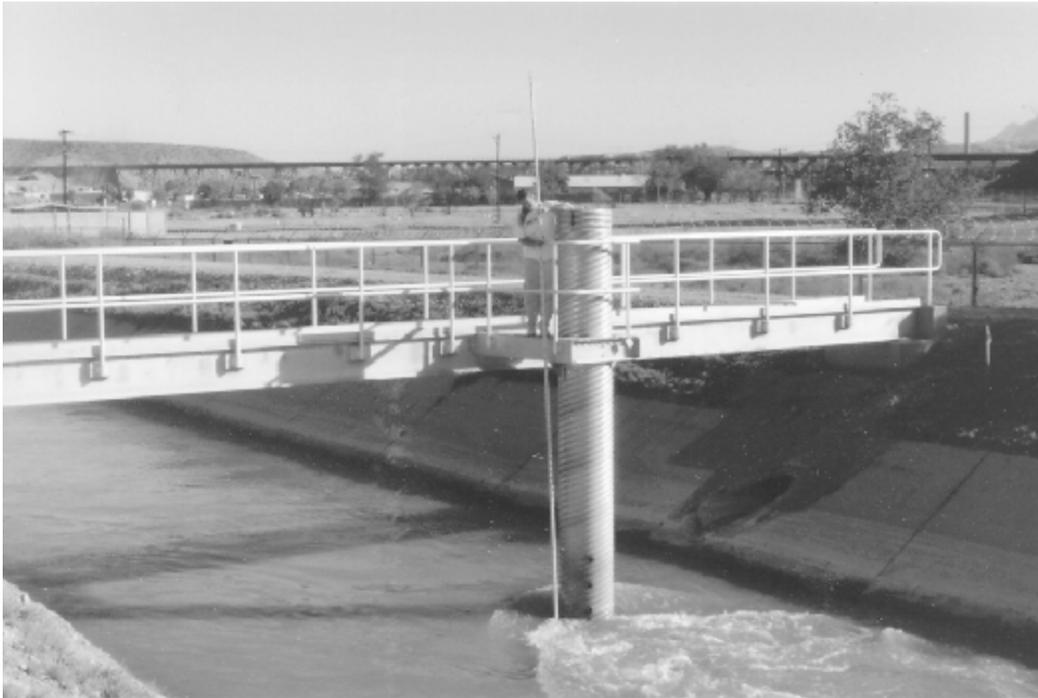
Plate 62. Bridge and Gauging Station in Open Channel "A" at 1742 ft from Headgates (1999).

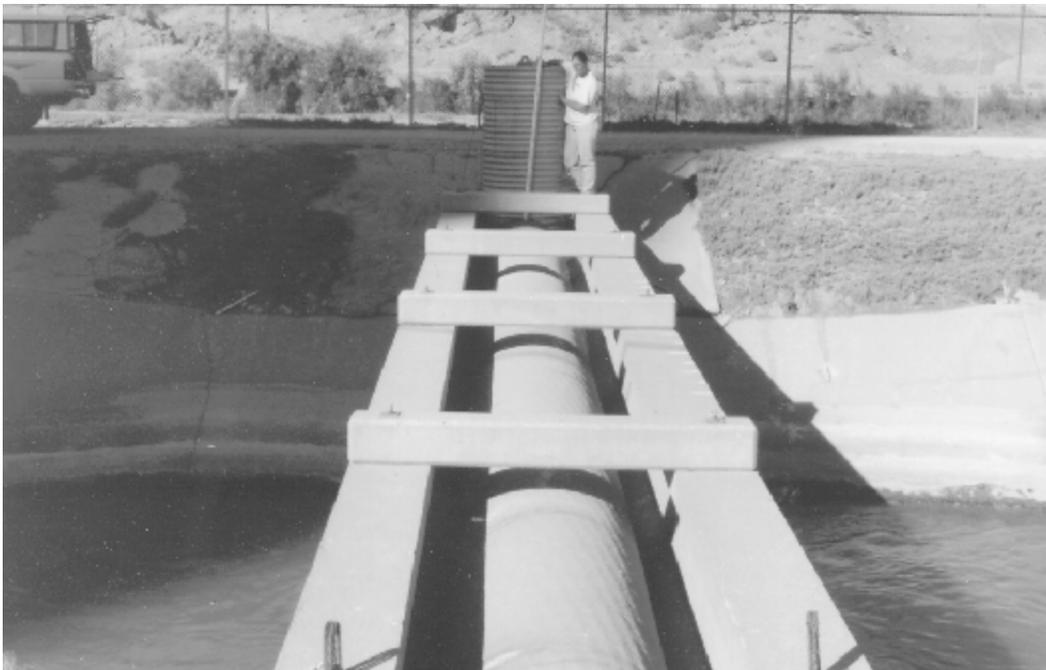
Plate 63. Gauging Station and Utility Crossing Above Closed Conduit "A" Looking North (1999).

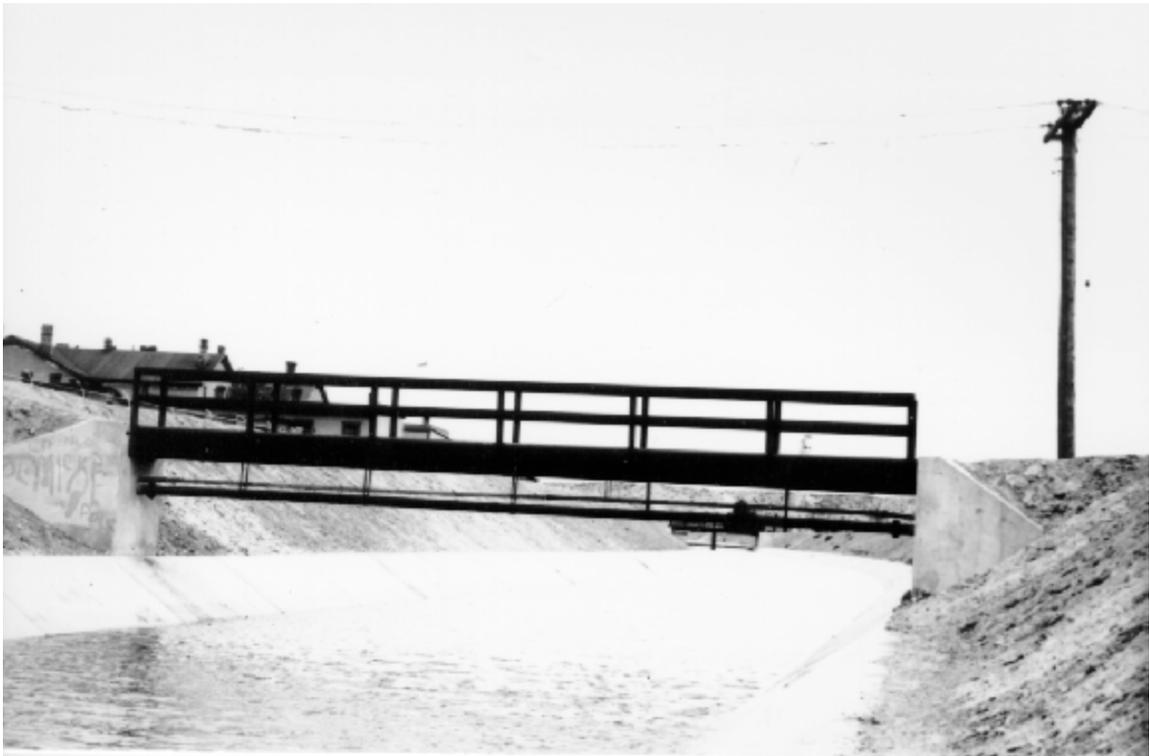
Plate 65. Globe Street Bridge, 15 May 1938.

Three bridges crossed the American Canal when it was completed in 1938. One was located at the U.S. 80 entrance into the ASARCO plant; the remaining two crossed the American Canal at the foot of Globe Street and at Hart's Mill (Plates 65 and 67).

Nominal specifications for all bridges indicate they were 41.5 ft long X 18 ft wide (see Figure BB-8 and BB-9 in Appendix BB). All were constructed of 0.33 x 1.33 x 21 ft stringers with a decking built of 0.25 x 0.67 X 18 ft wooden planks. A 15.5 ft tall wooden piling with cross-bracing located in the center of the structure provided additional support. Concrete abutments at both ends anchored the bridges firmly into the canal berms.

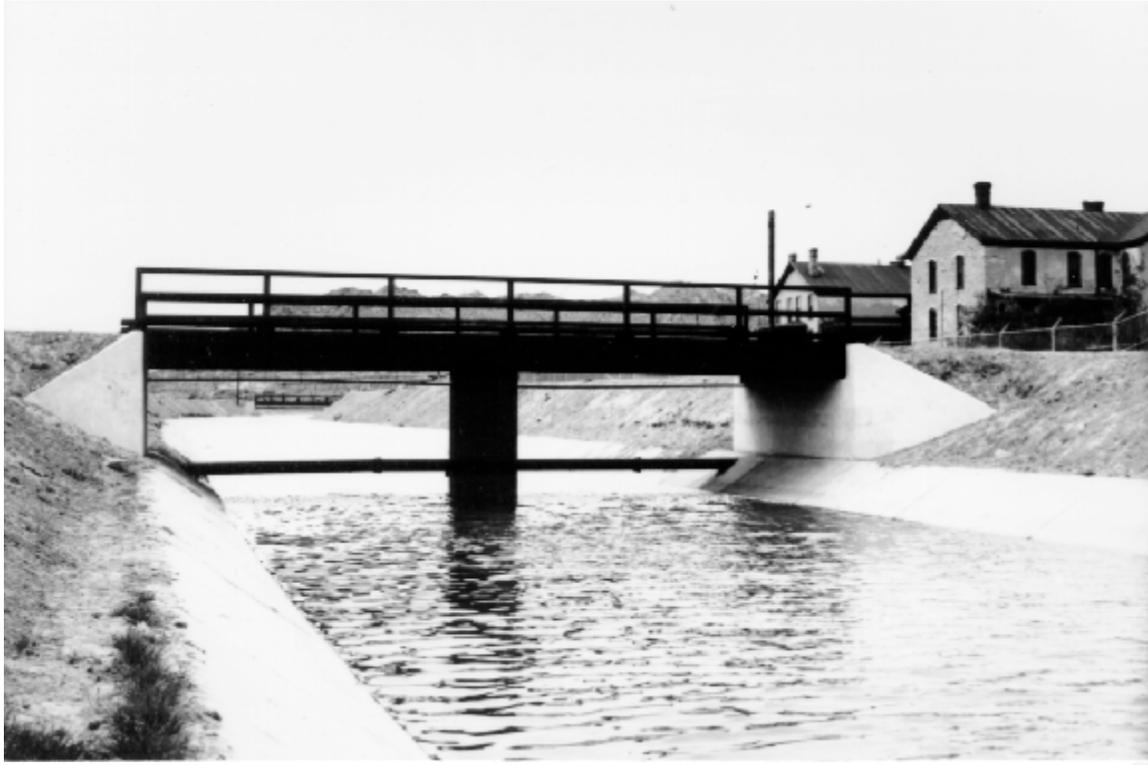
Plate 67. Hart's Road Bridge, 15 May 1938.

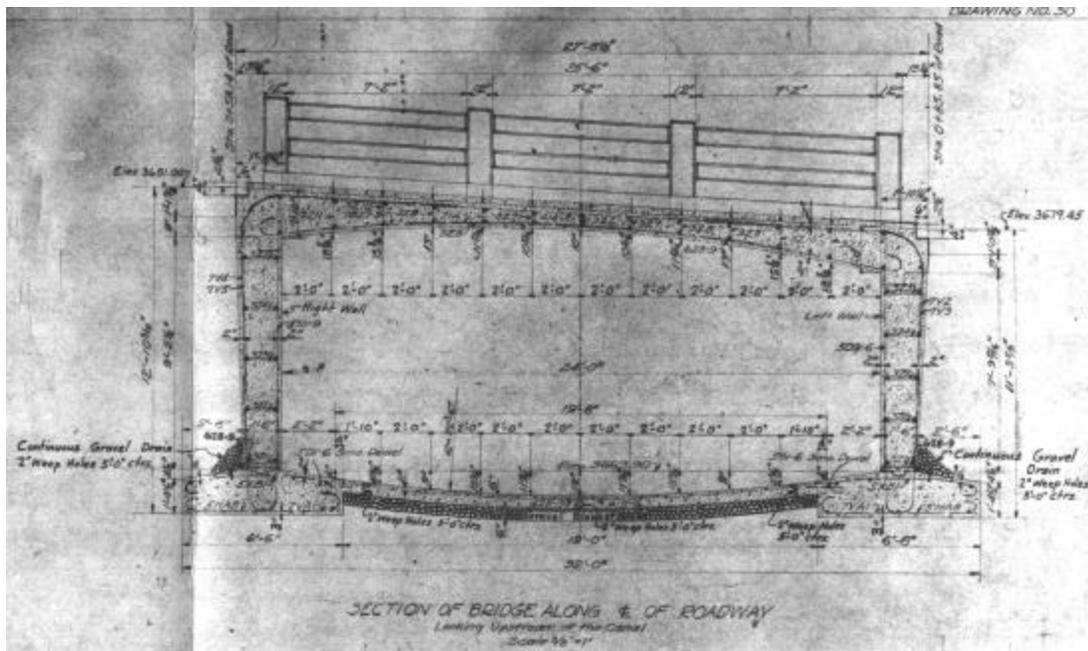
Plate 1: Section of Smelter Bridge, February 10, 1937.

Source: Construction drawing for Smelter Bridge and Transitions. Courtesy of USIBWC.

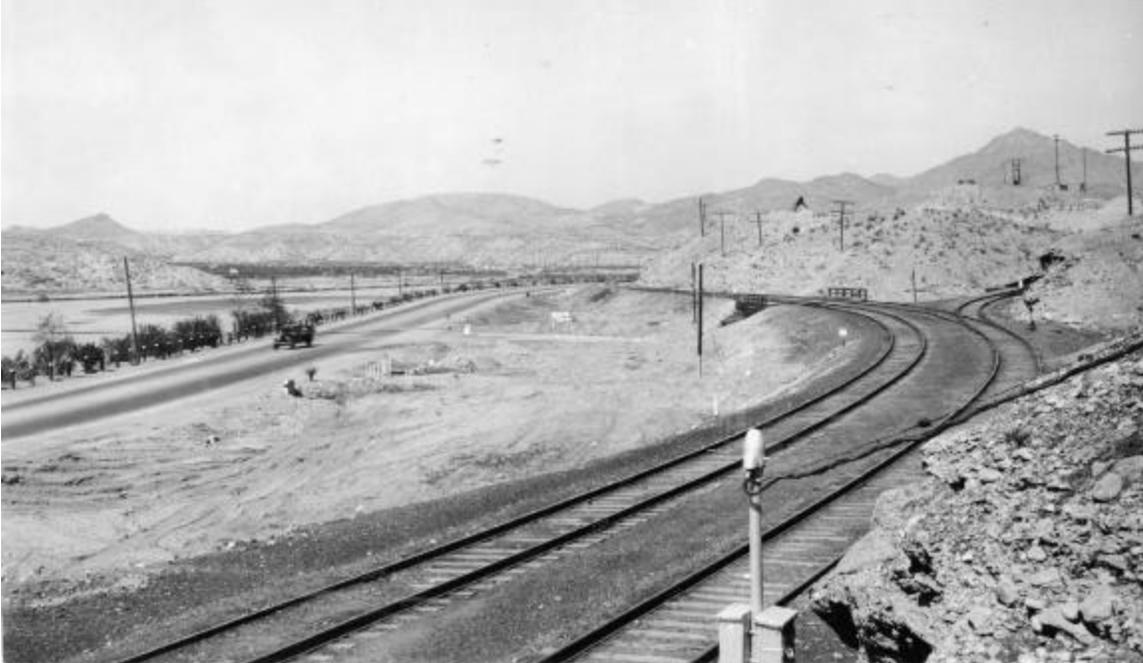
Plate 2: View prior to construction of the Smelter Bridge or American Canal, looking west, March 31, 1937.

Plates 1 through 5 illustrate the construction of the Smelter Bridge, and include a portion of the original construction drawing (Plate 1), a view of the land prior to construction (Plate 2), the pouring of the concrete deck (Plate 3), and its appearance upon completion (Plates 4 and 5). Additionally, two contemporary views of the bridge are included in order to illustrate that the Smelter Bridge remains largely intact and relatively unchanged (Plates 6 and 7). However, it should be noted that the images offered in this supplemental report represent only a sampling of the documentation that exists for both the Smelter Bridge and the American Canal and were selected as representative views.

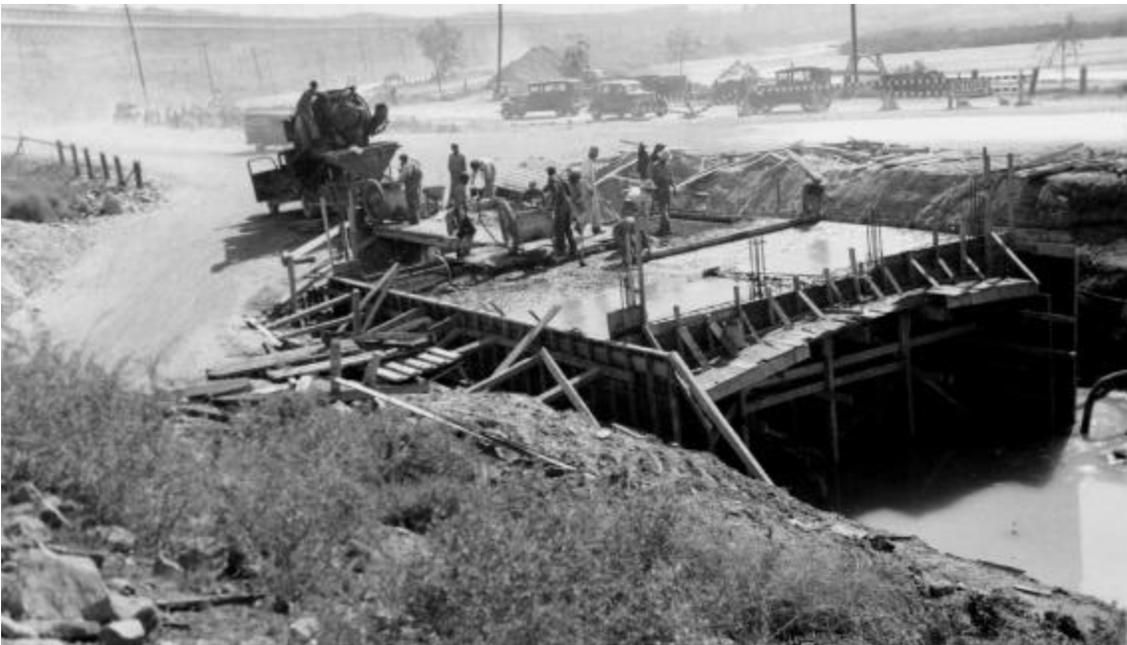
Plate 3: Pouring the concrete deck for Smelter Bridge, looking southeast, October 29, 1937.

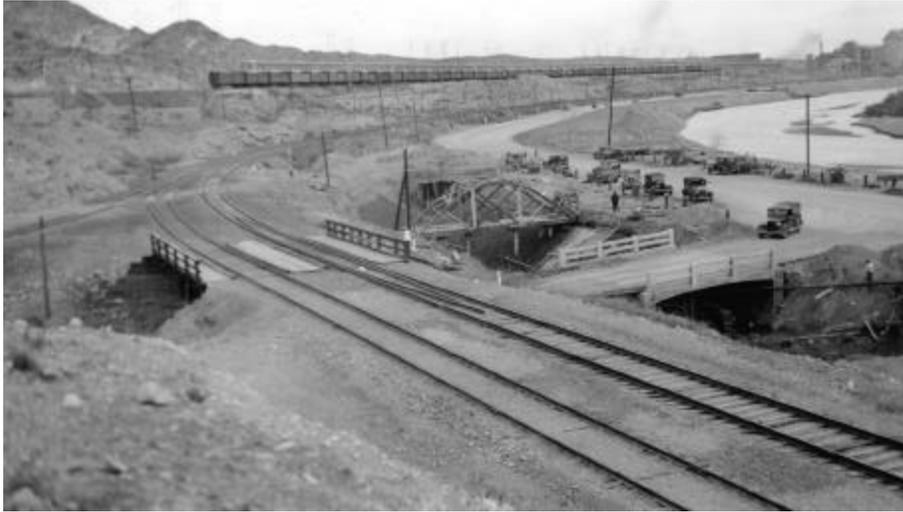
Plate 4: View of the completed Smelter Bridge and the construction of the American Canal, looking south, December 31, 1937.
Source: USIBWC Archives, Photograph No. 302.
