APPENDIX K

CONTROLLING WATER ON THE BORDER:
THE AMERICAN CANAL SYSTEM,
INTERNATIONAL BOUNDARY AND WATER COMMISSION,
EL PASO, TEXAS

Prepared for
United States Section
International Boundary and Water Commission
United States and Mexico
El Paso, Texas
Contract #IBM 96-23

November 1999
HSR Report No. 9904

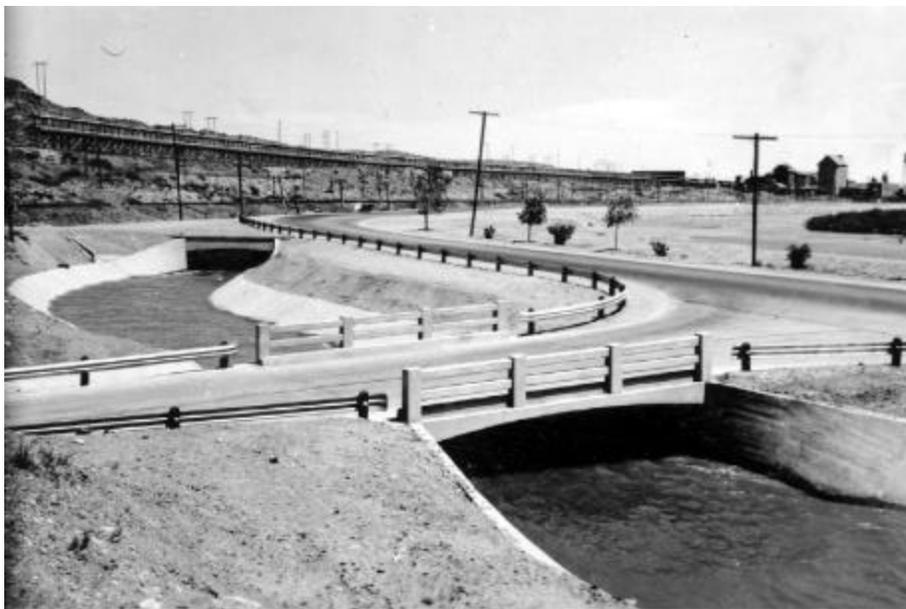
Plate 5: View of the Smelter Bridge and American Canal, looking south, June 11, 1938.
Source: USIBWC Archives, Photograph No. 1586.

Plates 1 through 5 illustrate the construction of the Smelter Bridge, and include a portion of the original construction drawing (Plate 1), a view of the land prior to construction (Plate 2), the pouring of the concrete deck (Plate 3), and its appearance upon completion (Plates 4 and 5). Additionally, two contemporary views of the bridge are included in order to illustrate that the Smelter Bridge remains largely intact and relatively unchanged (Plates 6 and 7). However, it should be noted that the images offered in this supplemental report represent only a sampling of the documentation that exists for both the Smelter Bridge and the American Canal and were selected as representative views.

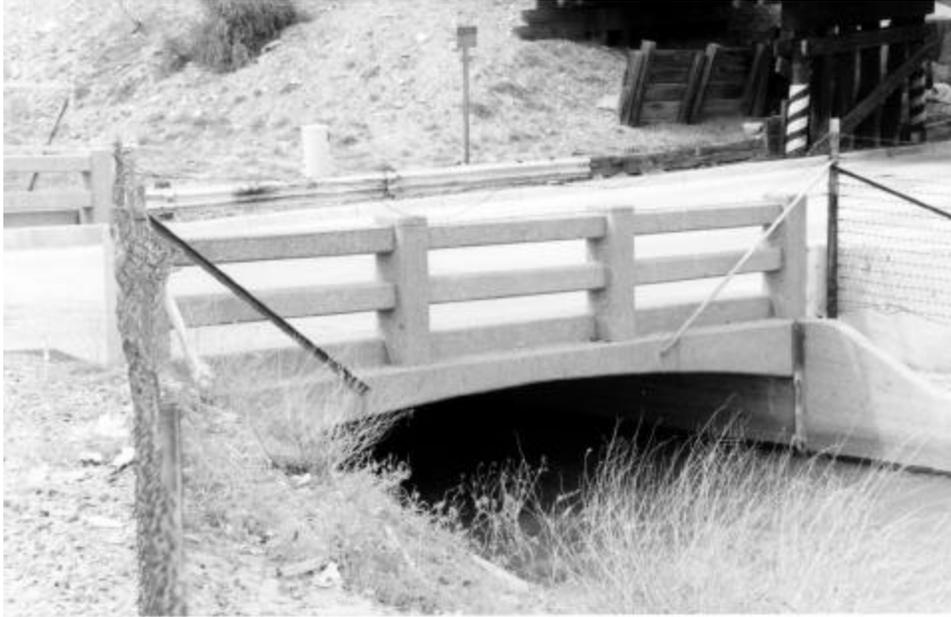
Plate 6: View of Smelter Bridge from the eastern side of Paisano Drive, looking northeast, March 20, 2000.

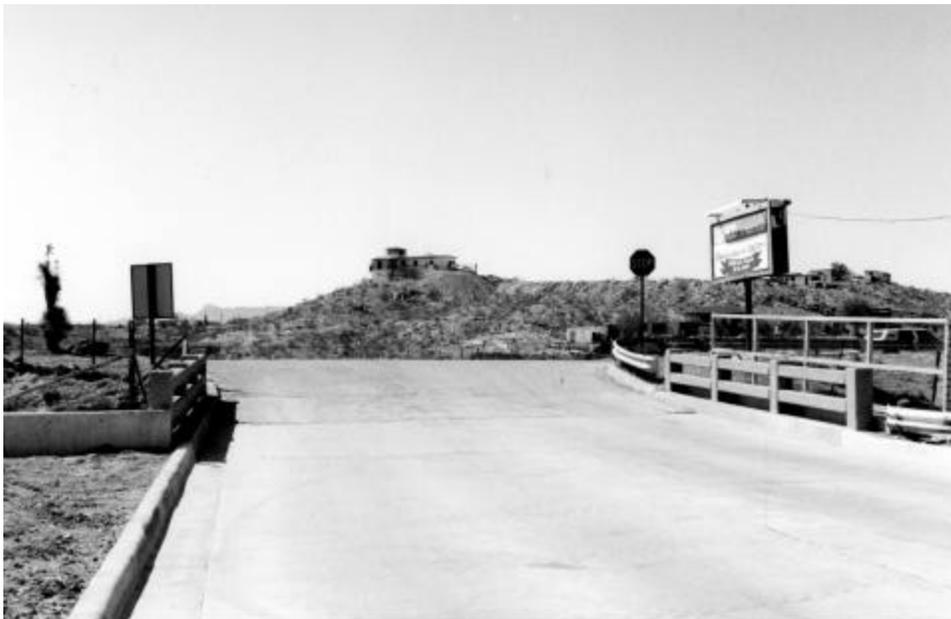
Plate 7: View of Smelter Bridge toward Paisano Drive, looking west, March 21, 2000.
