Lower Rio Grande Flood Control Project

Arroyo Colorado Post Flood Cleanup

March 23, 2011

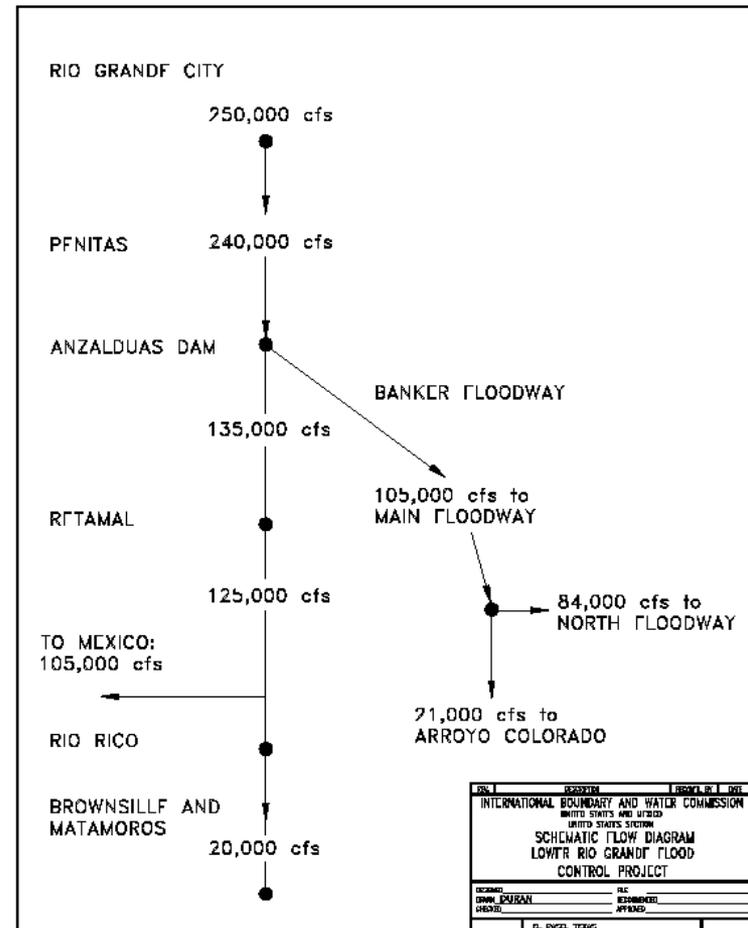
Exhibit 2

Schematic Flow Diagram Lower Rio Grande Valley

Mexico and the United States
equally divide flood flows

The Arroyo Colorado is required
to convey 21,000 cfs

During Hurricane Alex, on July
22, 2010, the Arroyo Colorado
flow measured 5,460 cfs, with
limited freeboard demonstrating
the need to improve its hydraulic
efficiency

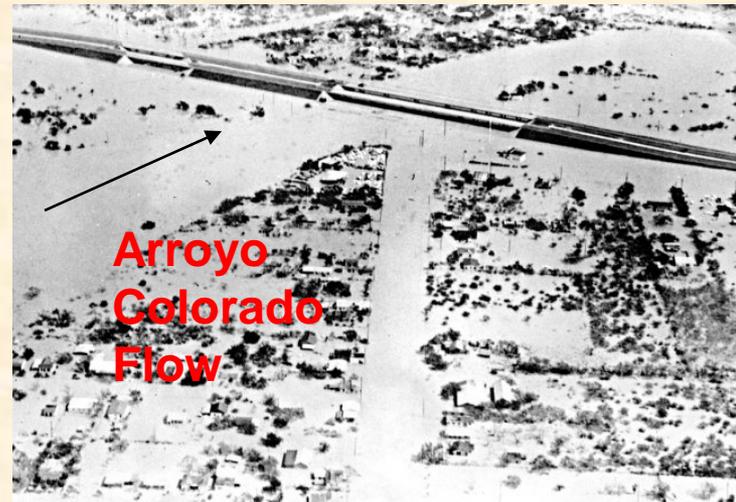
- Hurricane Beulah September 1967 flooded Harlingen via the Arroyo Colorado
- A weir failed causing 60,000 cfs to flow into the Arroyo Colorado
- A Divisor Dike was constructed in 1968 to ensure the arroyo will receive its design flow of 21,000 cfs during a major event

Hurricane
Beulah
1967
Hwy 77 At
Arroyo
Colorado

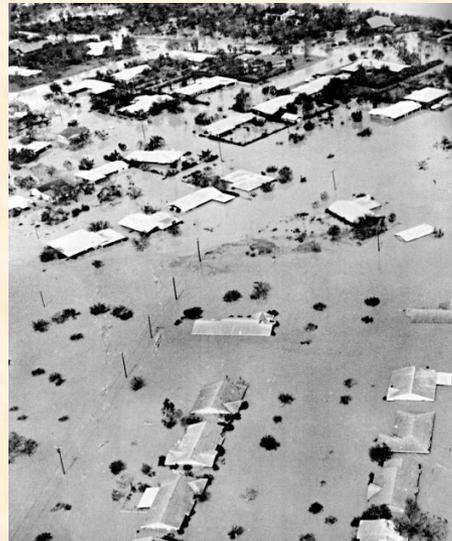
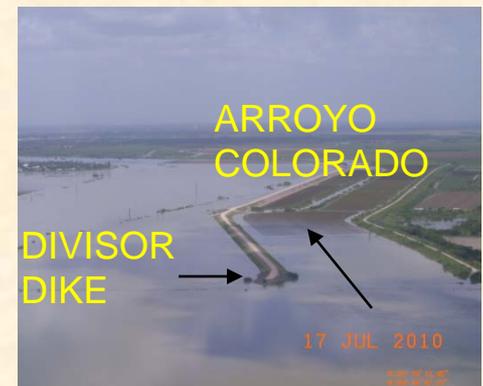
Flooding
Harlingen,
Texas
1967

Divisor Dike, Hurricane
Alex, Arroyo Colorado,
Mercedes, Texas

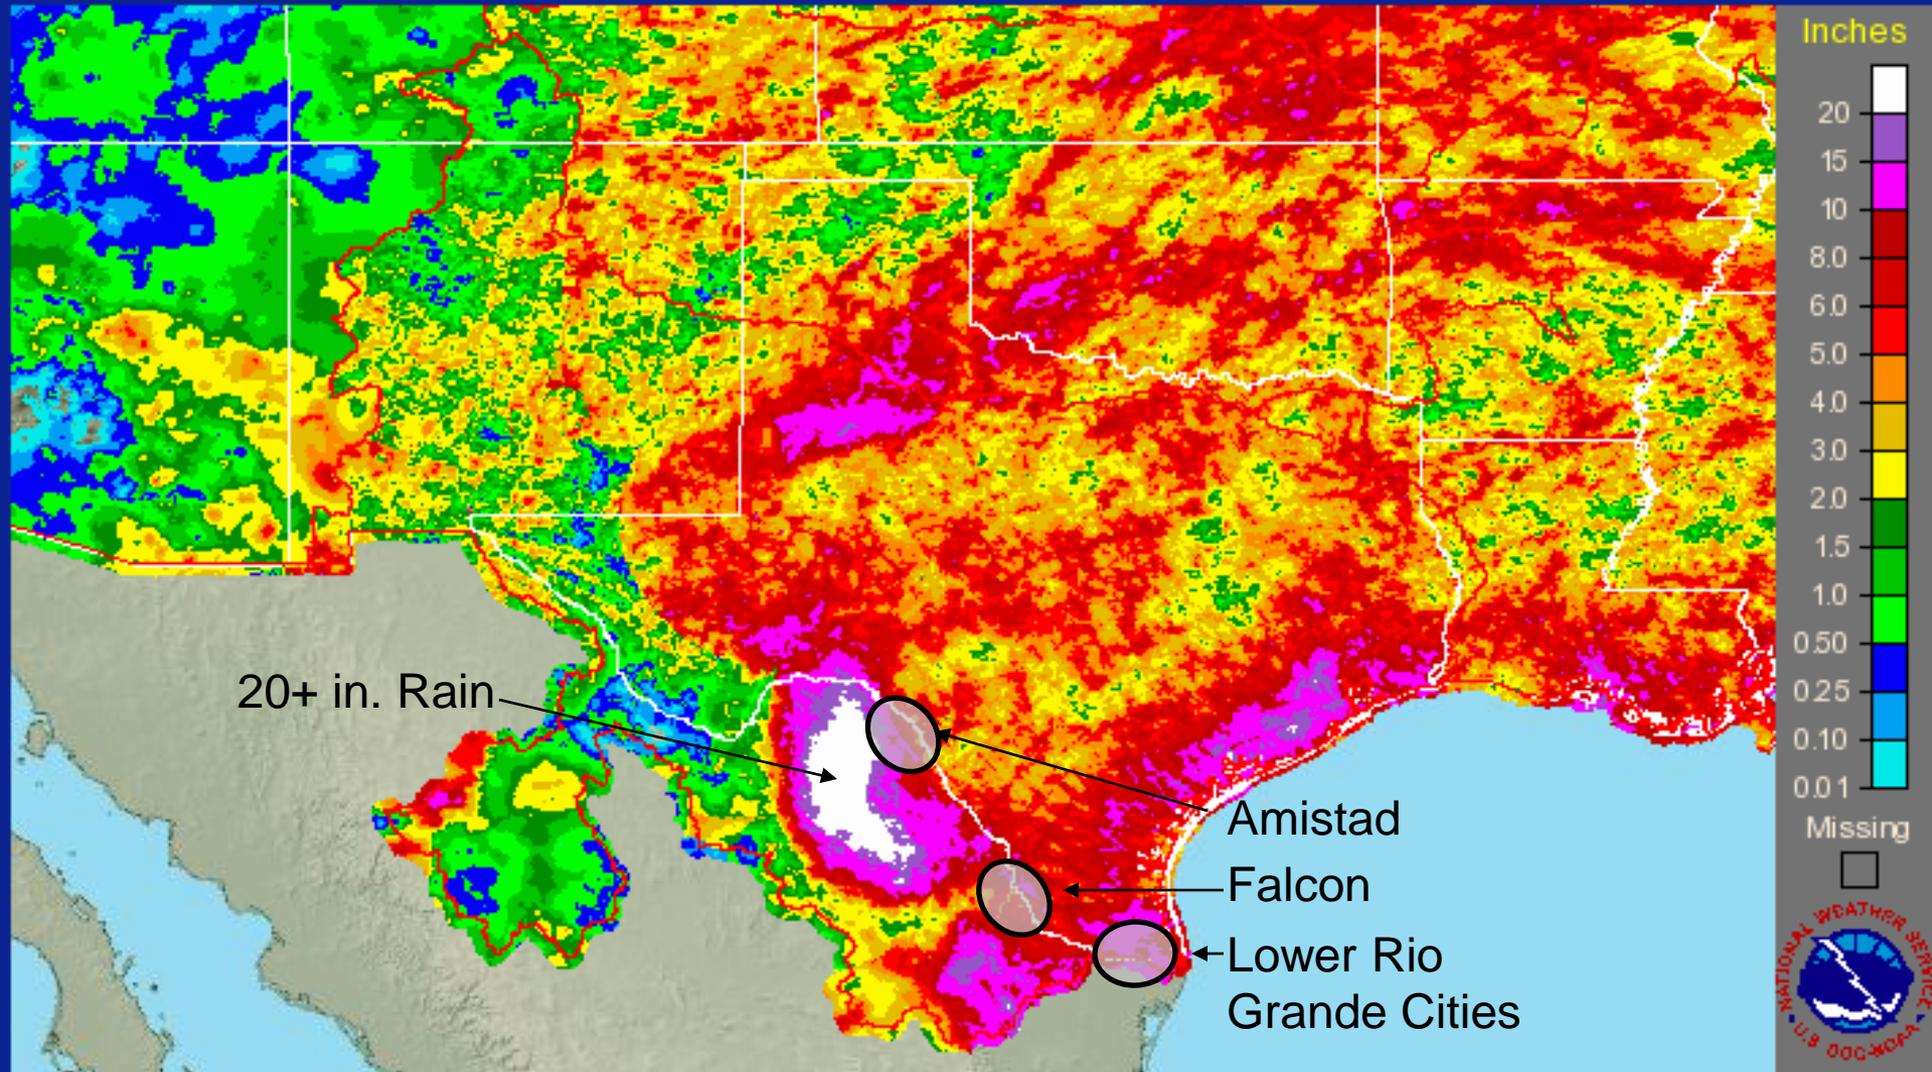
30-Day Rainfall Ending 24 July 2010

West Gulf RFC Ft Worth, TX
30-Day Observed Precipitation - Valid 7/24/2010 1200 UTC

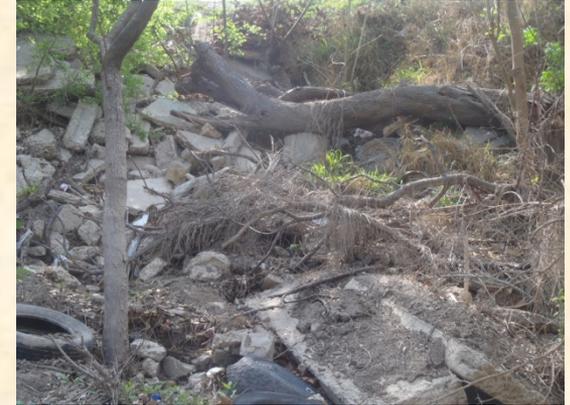
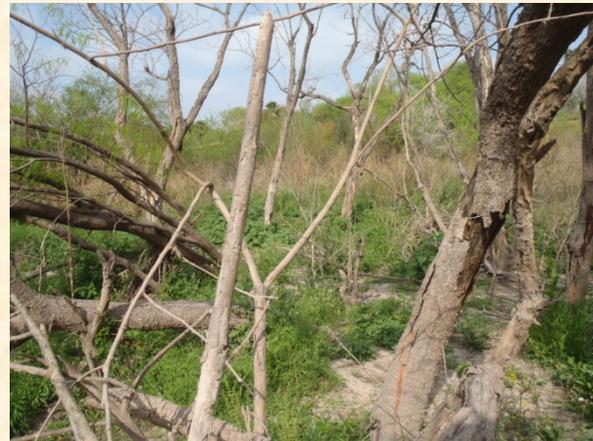
Arroyo
Colorado
Photo taken
3-9-11

Dead Trees to
be removed
Photo taken
3-9-11

- USIBWC will remove trash and dead trees below the 21,000 cfs flow line
- USIBWC will notify land owners of the cleanup
- During the cleanup USIBWC will have an environmental monitor

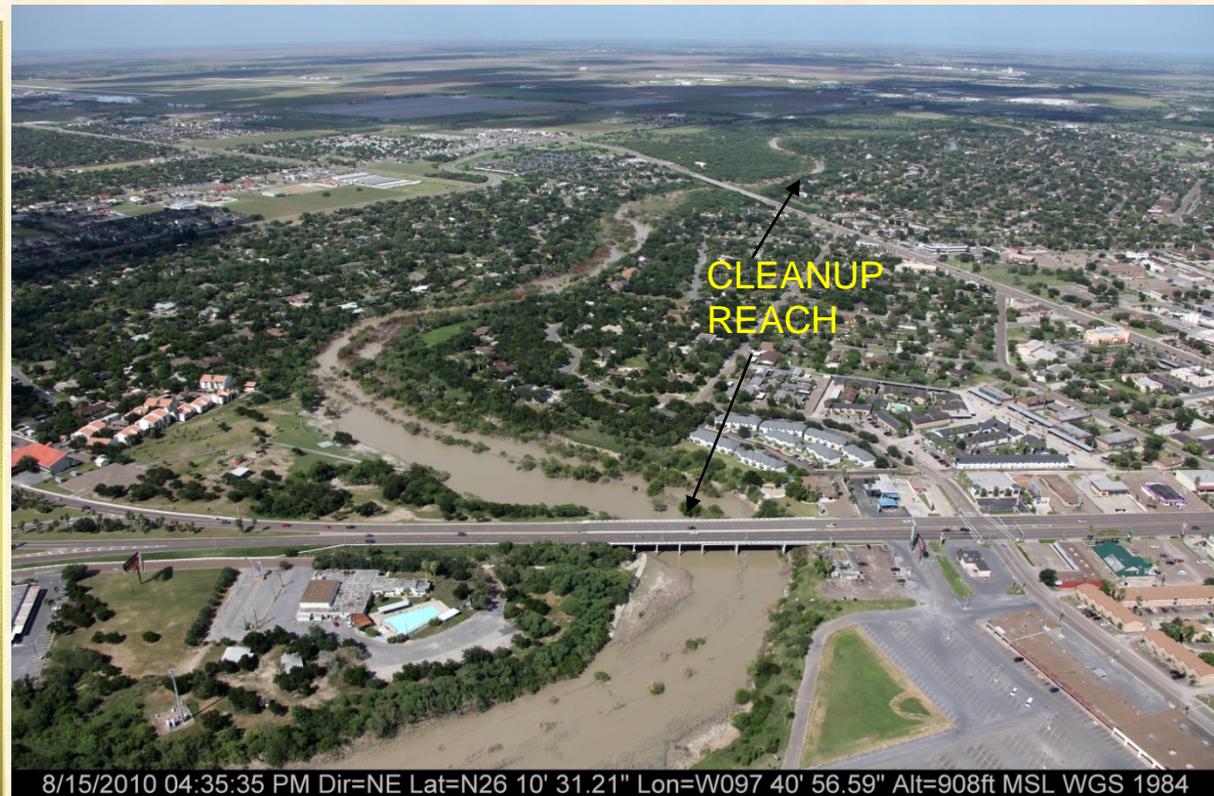
- Flows one month after Hurricane Alex
- Note trees within the flow
- Note brown fringe of dead trees within the arroyo

Arroyo Colorado Flow - August 15, 2010
