# Tijuana River Valley Trash, Waste Tire and Sediment Characterization Study

## A Status Update

International Boundary and Water Commission  
United States Section

**USIBWC Citizens Forum**  
**October 22, 2009, 6 - 8 p.m.**

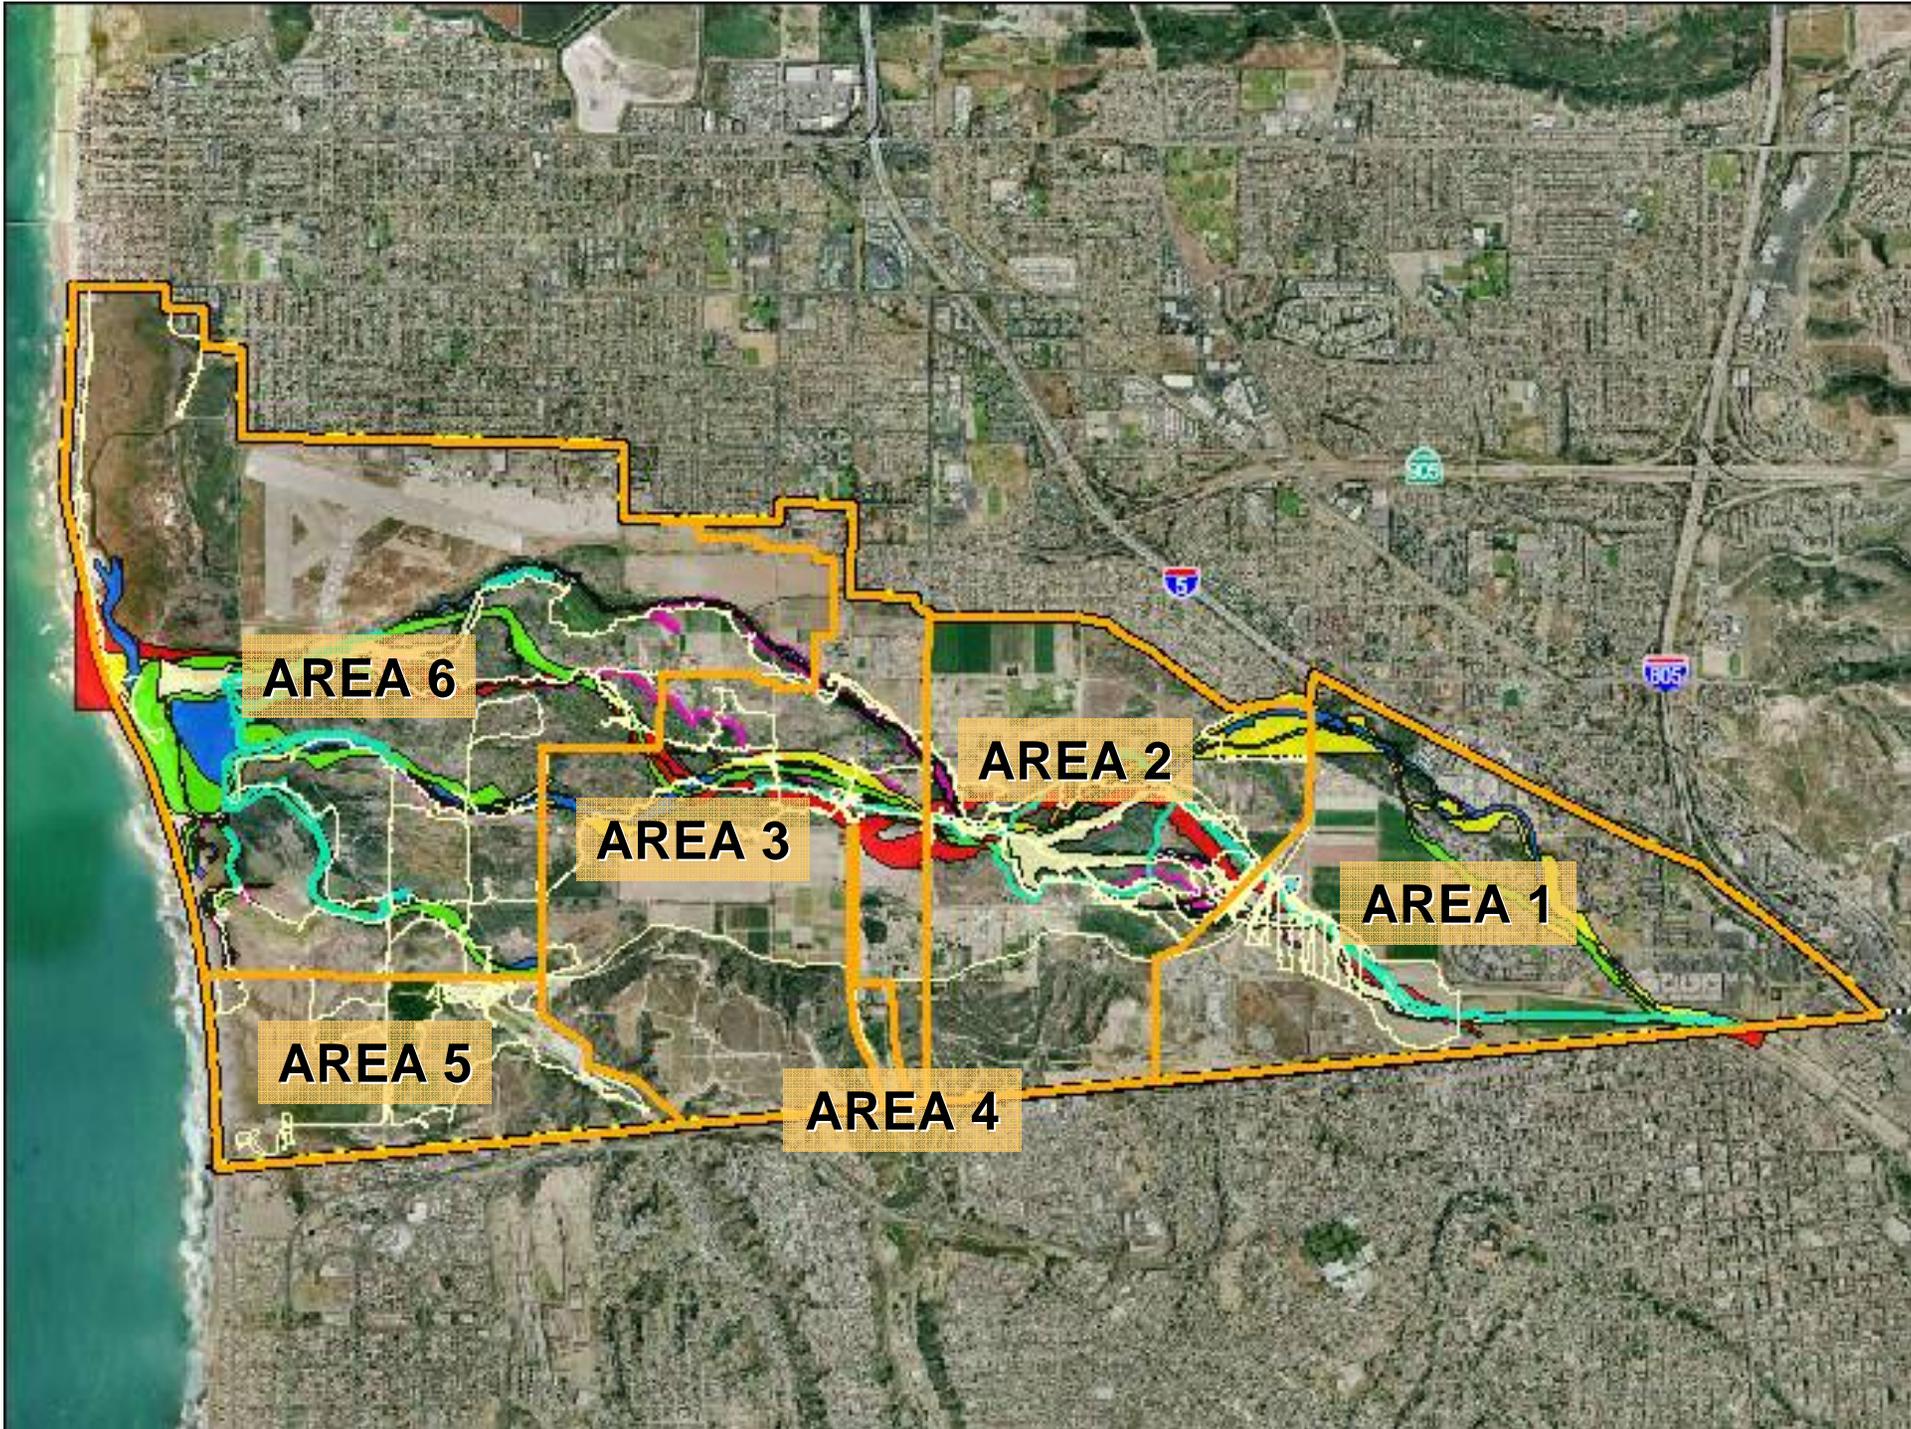
**AREA 6**

**AREA 2**

**AREA 3**

**AREA 1**

**AREA 5**

**AREA 4**

- Divided valley into 6 areas, including state parks and federal land
- Conducted linear transects across open areas
- Paralleled water courses/channels in heavily vegetated areas
- Based observations on City descriptors
- Quantified by visually estimating % trash coverage of approximate areas
- Weighed trash in representative areas
- Used CIWMB solid waste categories
- Integrated representative areas to estimate total trash volumes by type

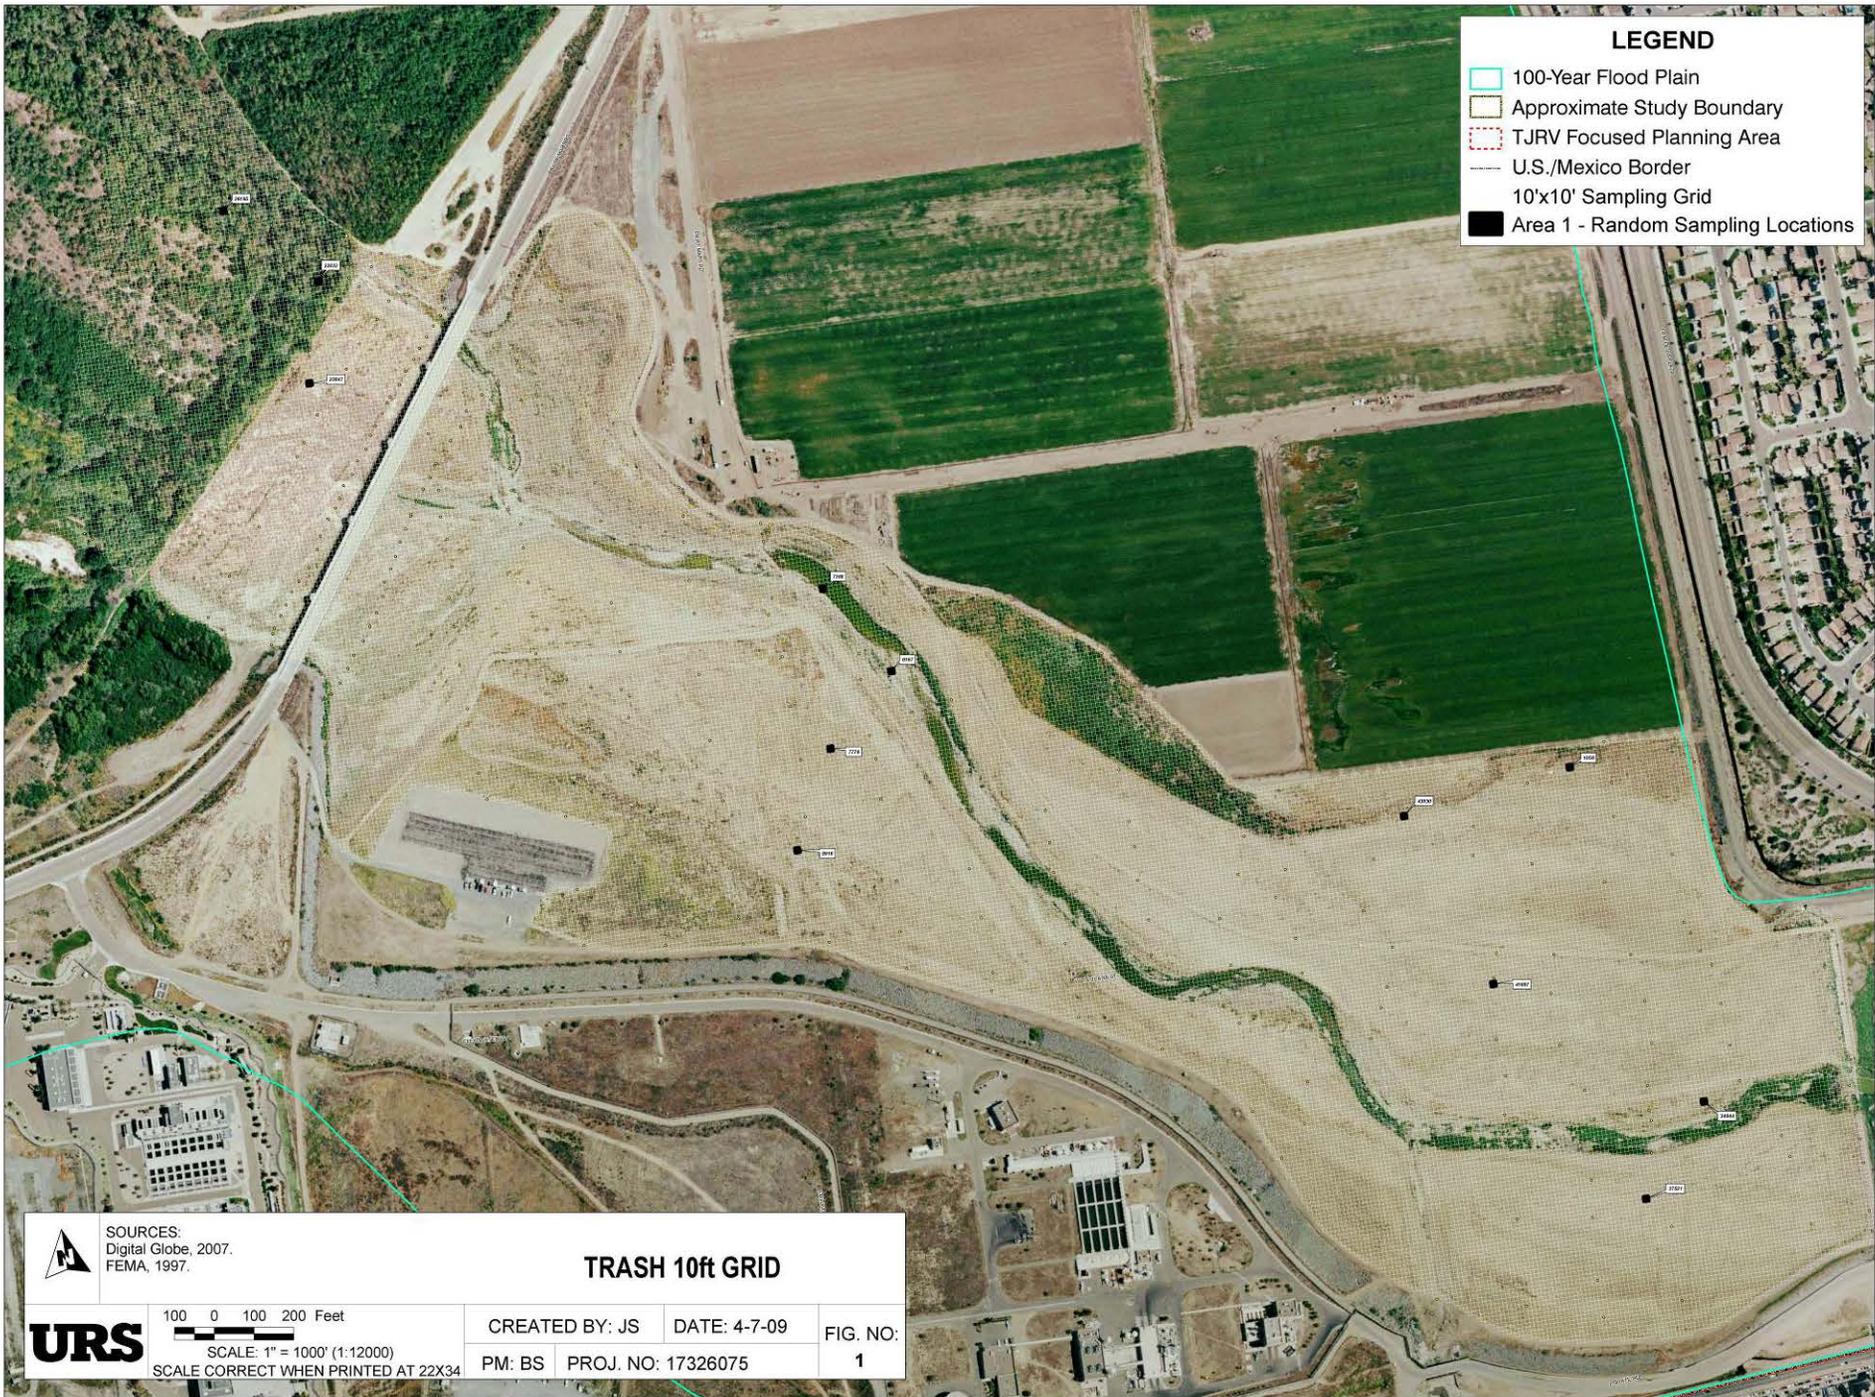
**TRASH 10ft GRID**

- 100-Year Flood Plain
- Approximate Study Boundary
- TJRV Focused Planning Area
- U.S./Mexico Border
- 10'x10' Sampling Grid
- Area 1 - Random Sampling Locations

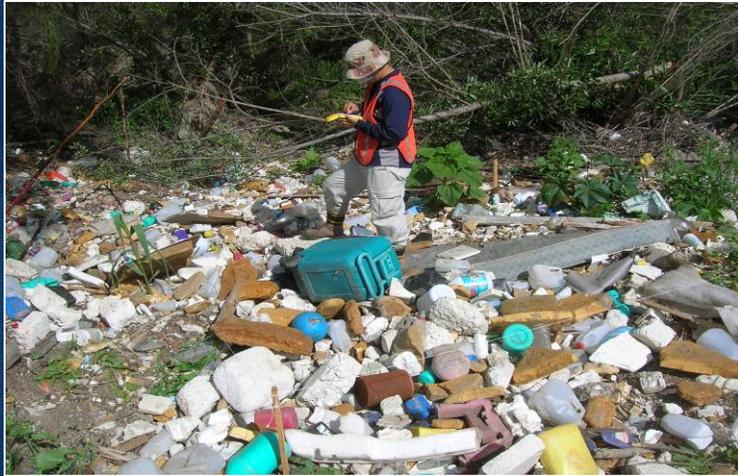
Measure and flag test plot

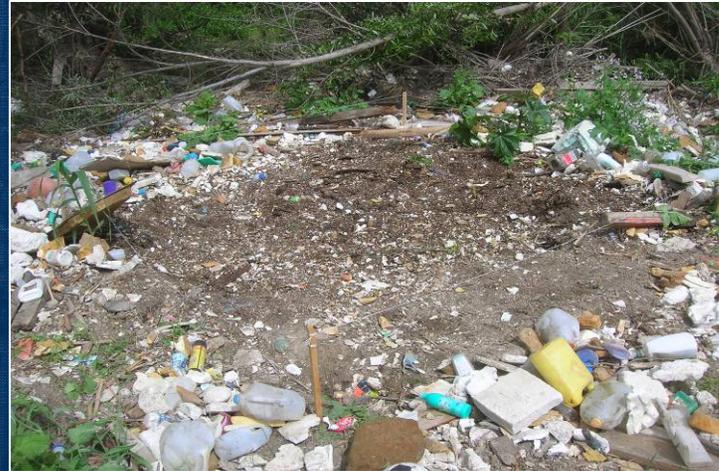
Collect trash

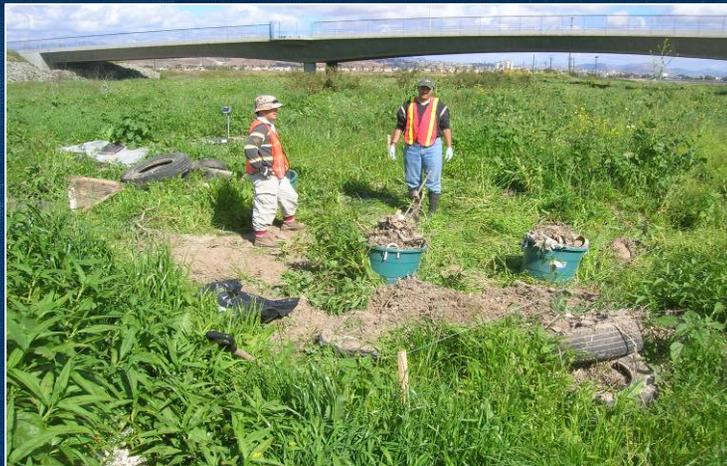
Sort trash by type

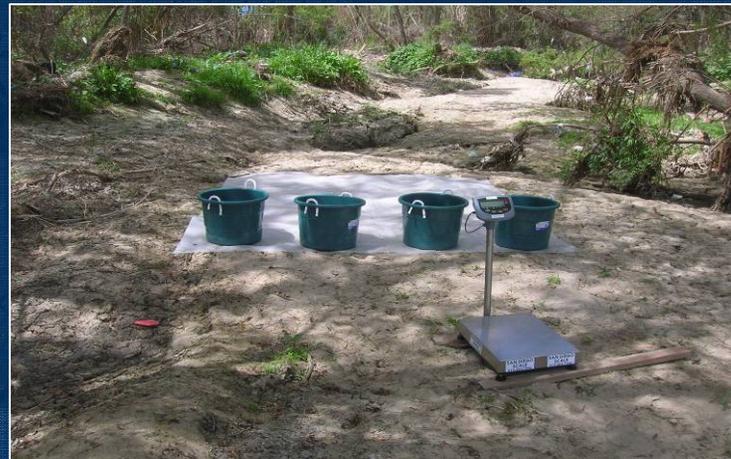
Weigh trash by type

Cell ID	Total Area	Weight % of Total			7368 Accumulation Area	
Cell Area (sf)	28196	Total	w/o Tires	w/o Tires	150	
Trash Coverage %				w/o branches stumps sediment	75 to 100%	
Waste Category	Weight (lbs) Sub-Totals	Weight % of Totals			Total lbs	Ave lbs/sf
<b>Paper</b>						
Cardboard	1.2	0.044%	0.063%	0.081%	0	0.000
Paper	0.6	0.022%	0.031%	0.041%	0.6	0.004
<b>Glass</b>						
Bottles	8.6	0.315%	0.449%	0.583%	0.7	0.005
<b>Metal</b>						
cans Al and Steel	8.3	0.304%	0.433%	0.563%	1	0.007
other	5.6	0.205%	0.292%	0.380%	0	0.000
<b>Electronics</b>						
Brown Goods	0	0.000%	0.000%	0.000%	0	0.000
Computer related	0	0.000%	0.000%	0.000%	0	0.000
<b>Plastic</b>						
PETE	72.8	2.666%	3.799%	4.936%	13.3	0.089
HDPE	60.4	2.212%	3.152%	4.095%	8.6	0.057
Durable Plastic	117.3	4.295%	6.121%	7.953%	10.4	0.069
Remainder /						
Composite	169	6.188%	8.820%	11.458%	12.1	0.081
<b>- Total Plastic</b>	<b>419.5</b>	<b>15.361%</b>	<b>21.892%</b>	<b>28.441%</b>	<b>44.4</b>	<b>0.296</b>
