River Restoration Activities in the Rio Grande Canalization Flood Control Project

Upper Rio Grande Citizens' Forum
Elizabeth Verdecchia
July 19, 2012

Rio Grande Canalization Flood Control Project

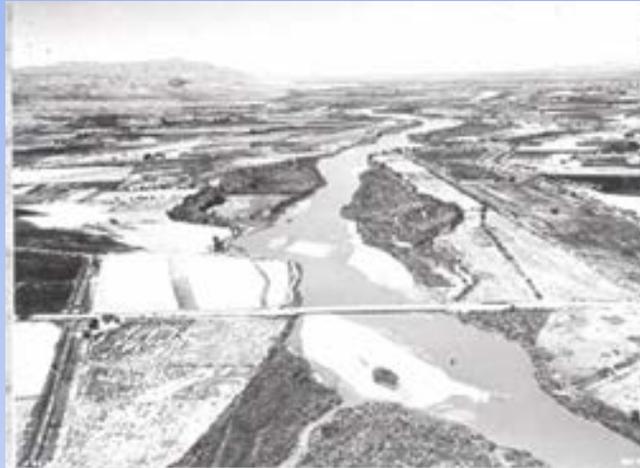
October 1938 - Canalization Project. Looking upstream on Rio Grande at Picacho Bridge (U.S. 80) near Las Cruces, New Mexico, prior to levee construction and channel stabilization.

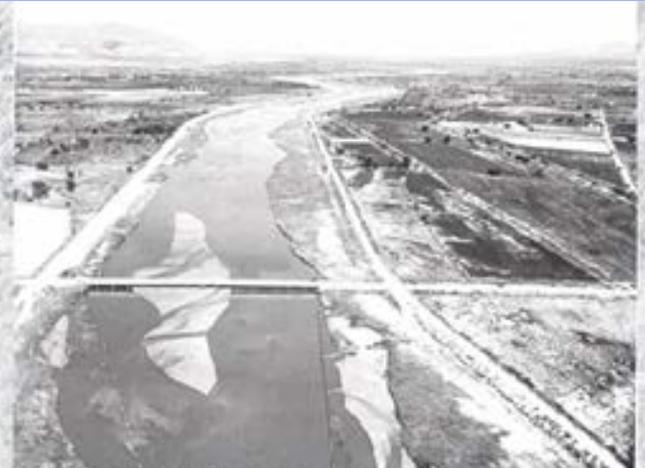
October 1942 - Same scene after levee construction and at start of channel stabilization works.

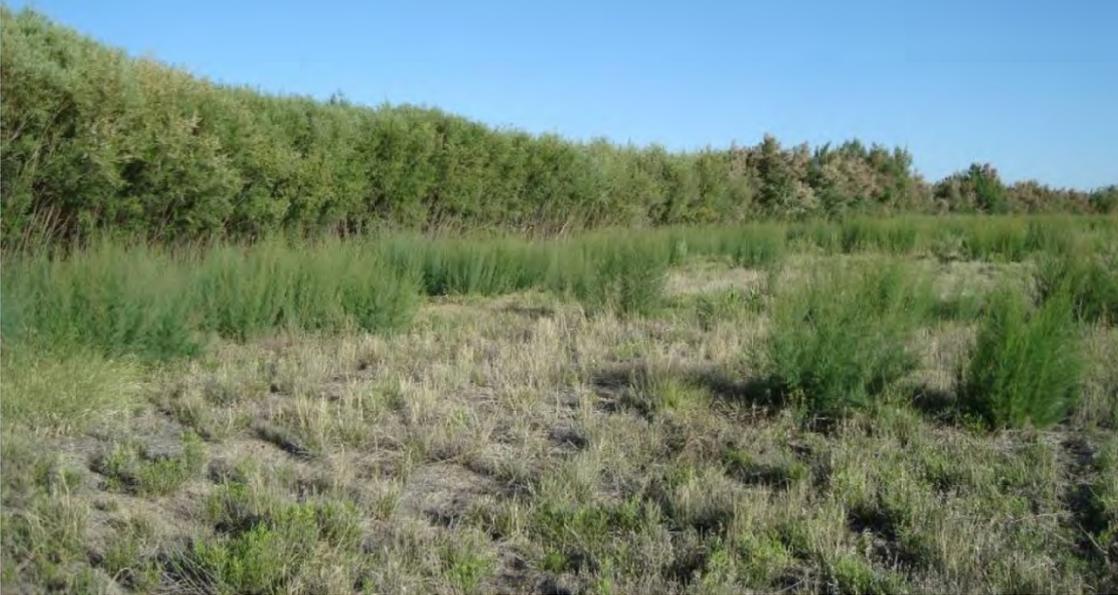
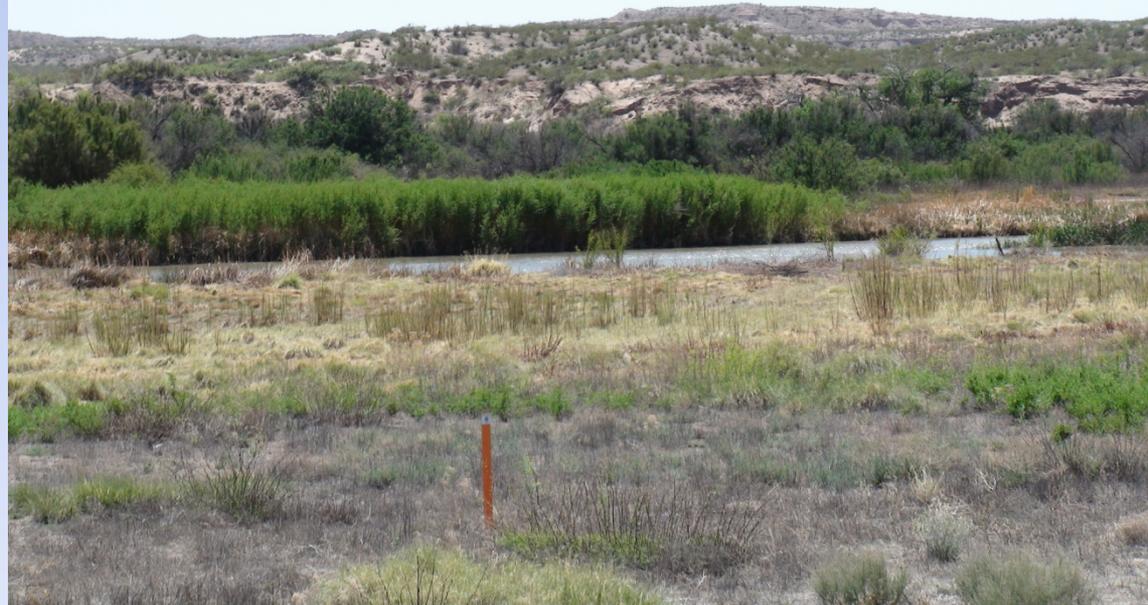
Crow Canyon

- 195 acres of salt cedar treated with herbicide
- Pole-plantings:
 - 187 black willows
 - 40 cottonwoods

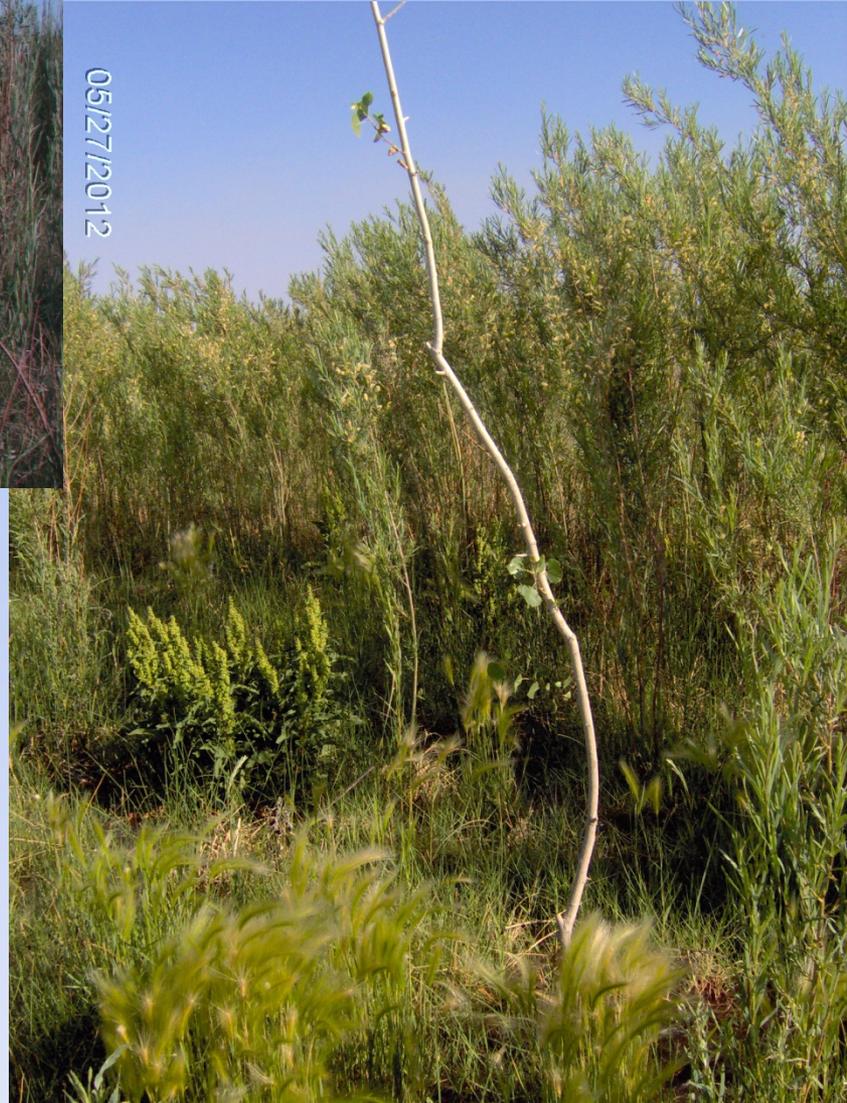
05/27/2012

- Native willows returning in now-mow areas

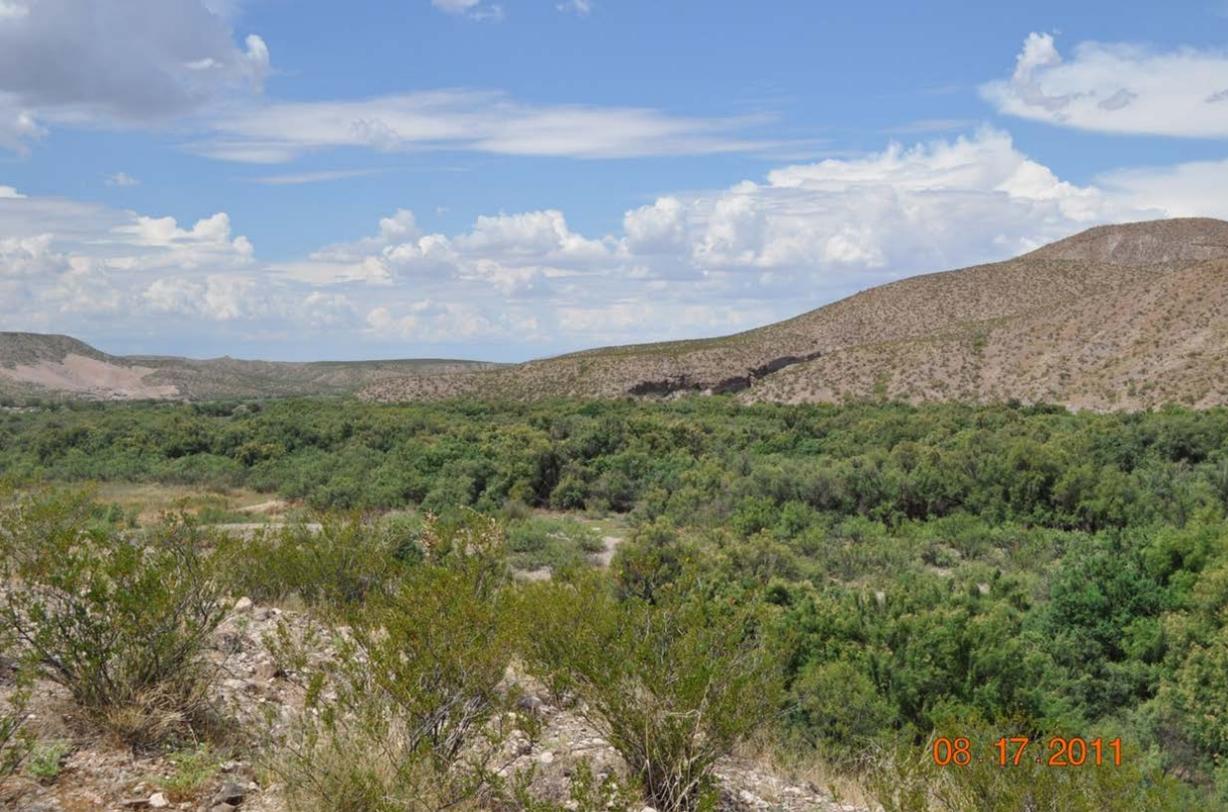
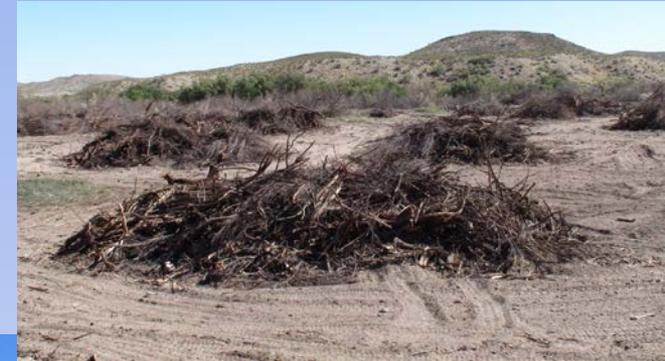
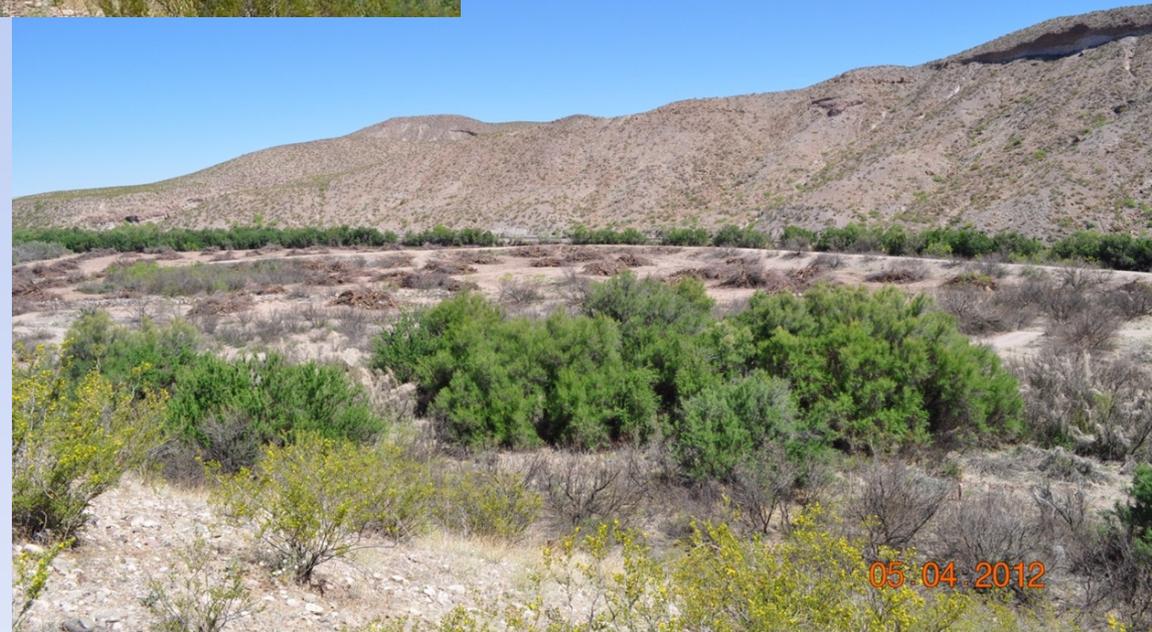
Broad Canyon Arroyo Site

- 20 acres of salt cedar treated by excavator
- 8.5 acres left where YBC was observed

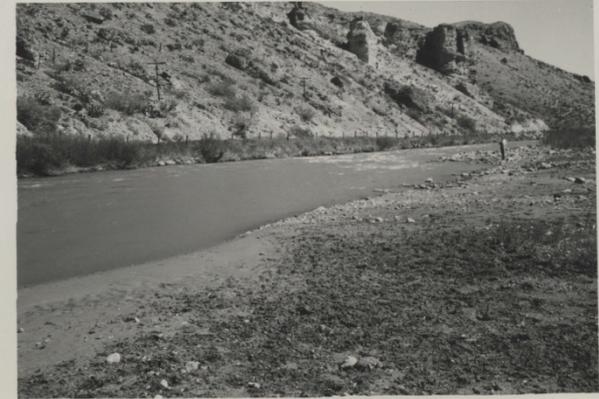
LOOKING DOWNSTREAM AT RAPIDS IN RIVER AT MOUTH
OF BROAD CANYON, APRIL 25, 1940

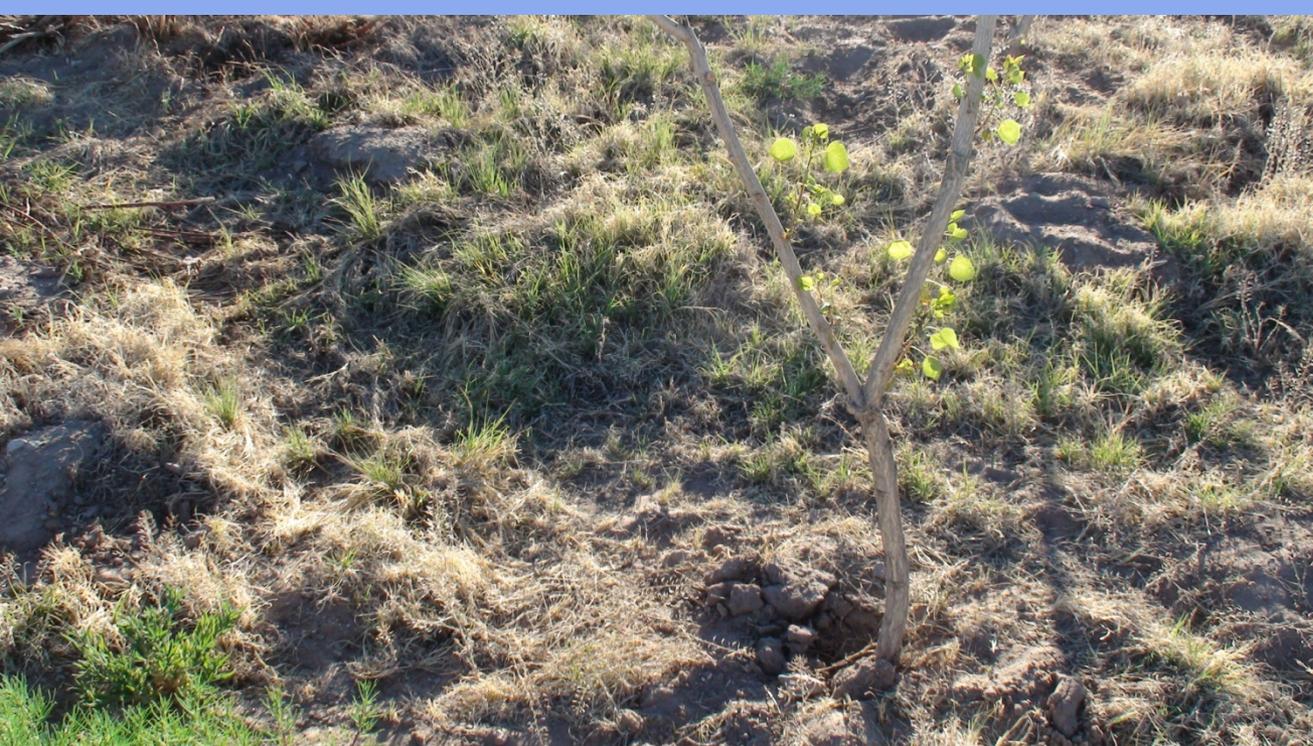
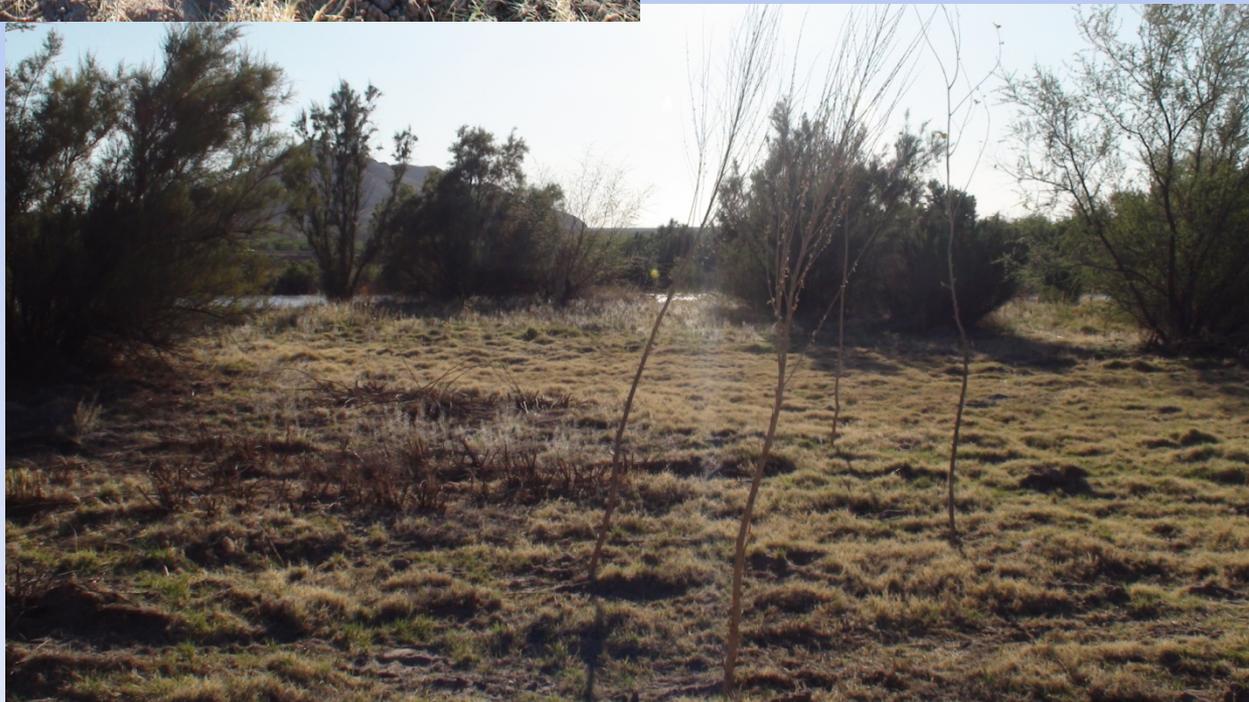
Leasburg Lateral

- Expanded to 30 acres
- Pole-plantings:
 - 61 black willows
 - 39 cottonwoods
- 26 acres salt cedar treated with stump cut herbicide treatment

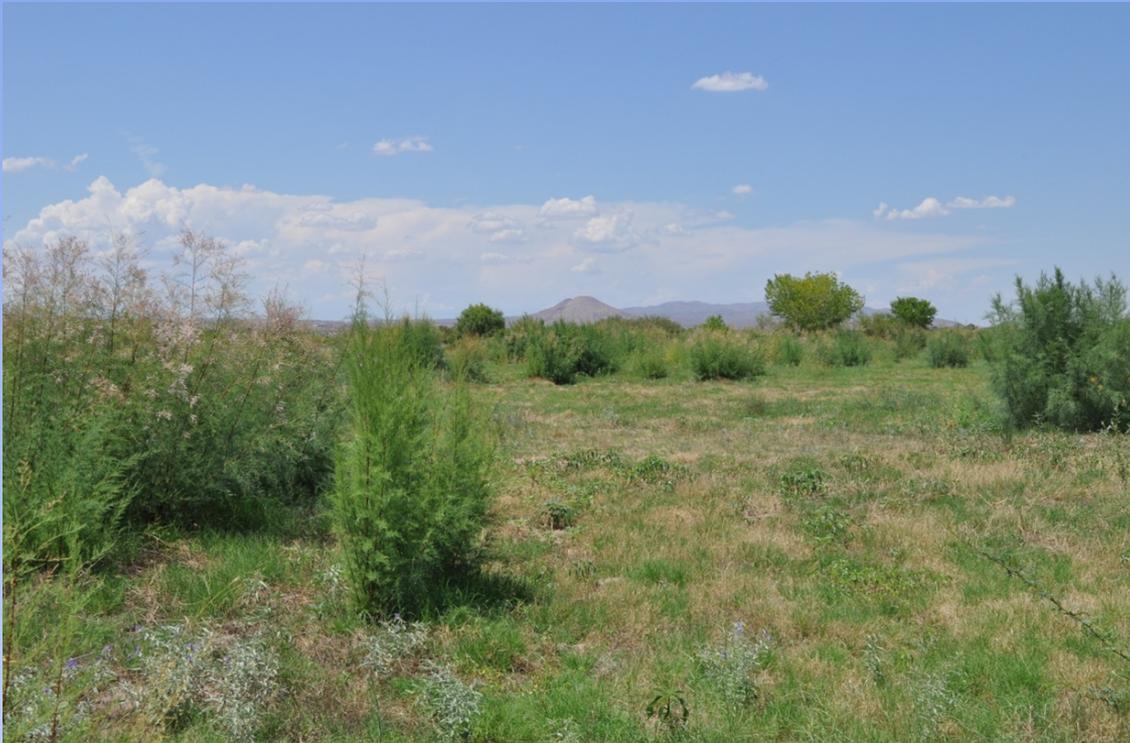
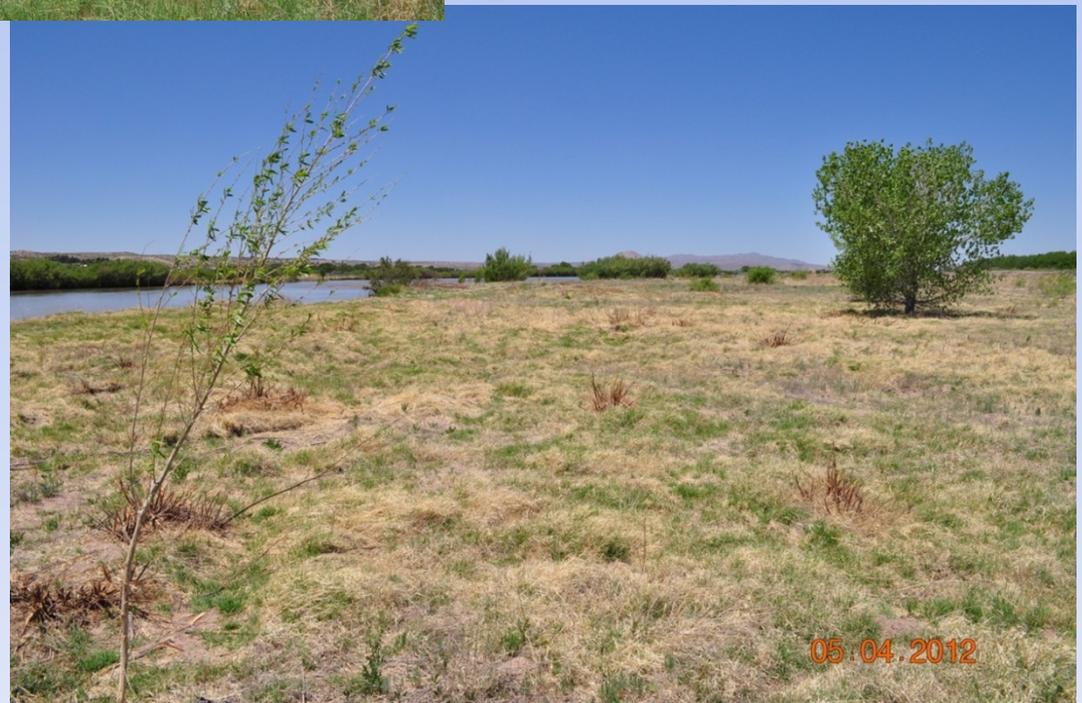
Mesilla East

- Expanded to 70 acres
- Pole-plantings:
 - 61 black willows
 - 39 cottonwoods
- 70 acres salt cedar treated with stump cut herbicide treatment
