Lower Rio Grande Flood Control Project

Arroyo Colorado Post Flood Cleanup

March 23, 2011

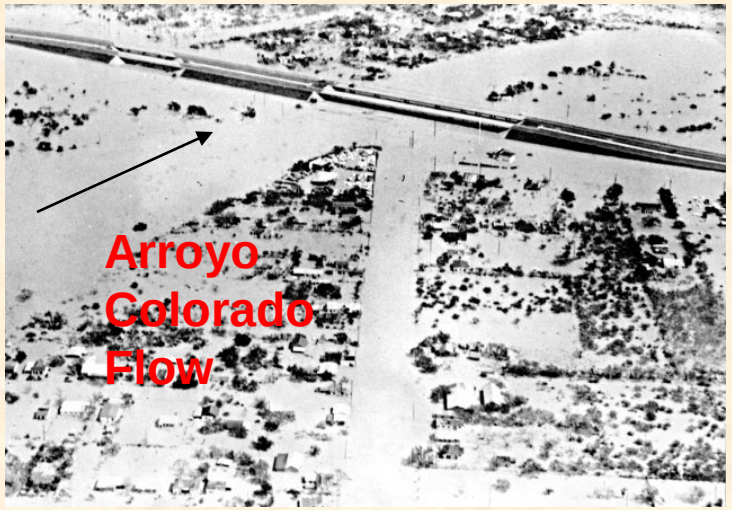
Hurricane Beulah 1967 Hwy 77 At Arroyo Colorado

- Hurricane Beulah September 1967 flooded Harlingen via the Arroyo Colorado
- A weir failed causing 60,000 cfs to flow into the Arroyo Colorado
- A Divisor Dike was constructed in 1968 to ensure the arroyo will receive its design flow of 21,000 cfs during a major event

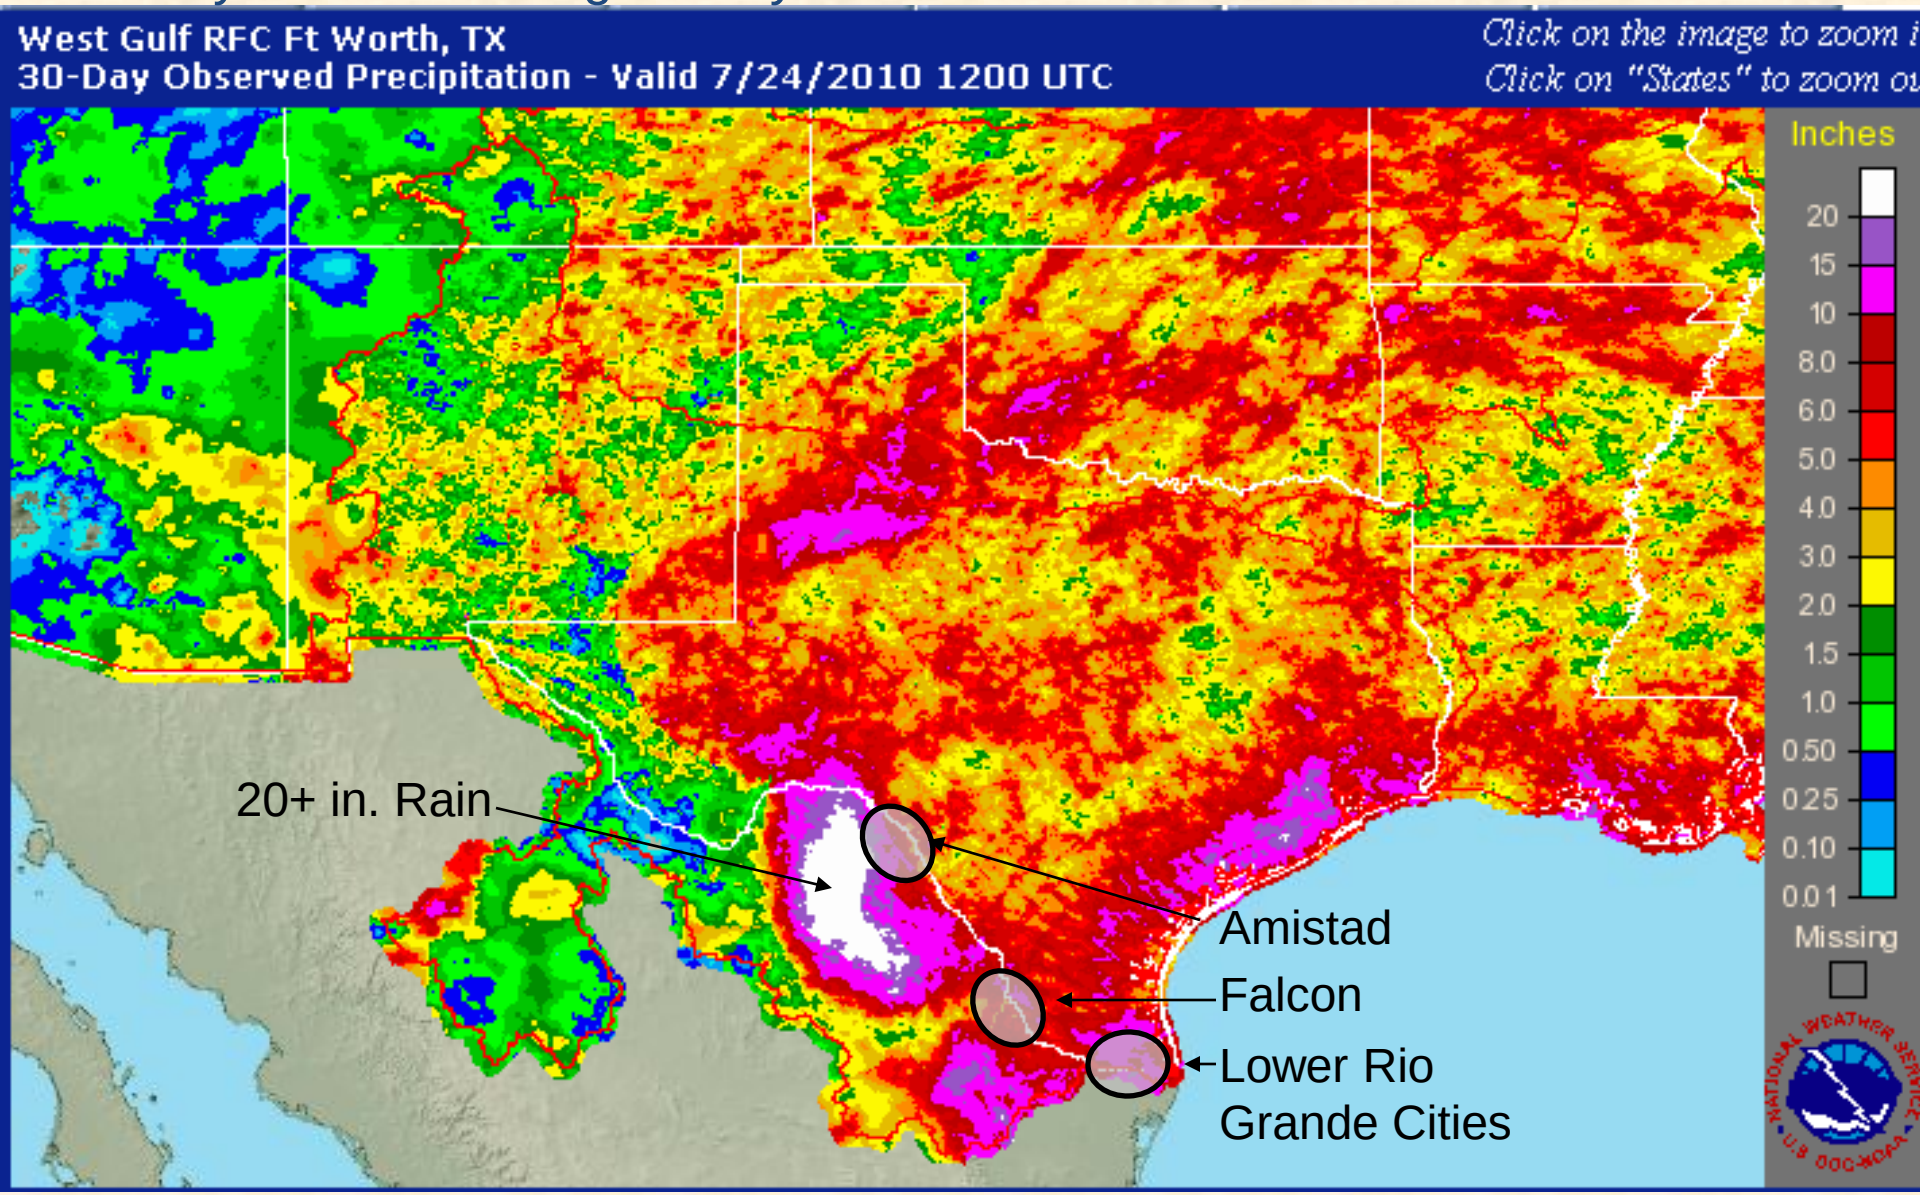
30-Day Rainfall Ending 24 July 2010

Hurricane Alex / Tropical Depression #2 Impacts
