International Boundary and Water Commission United States and Mexico

2008 ANNUAL REPORT

**INTERNATIONAL BOUNDARY AND WATER COMMISSION
UNITED STATES AND MEXICO**

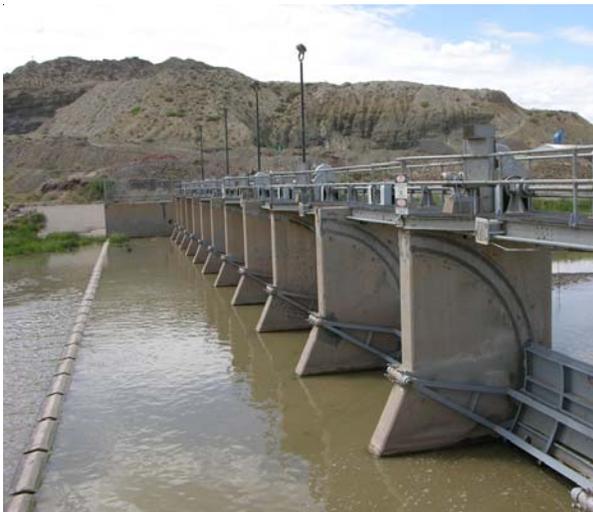
Three of American Dam's gates were replaced during 2008.

At American Dam, which diverts the U.S. share of water into the American Canal at El Paso, the U.S. contractor completed a project to replace 3 of the dam's 13 gates and to install cathodic protection.

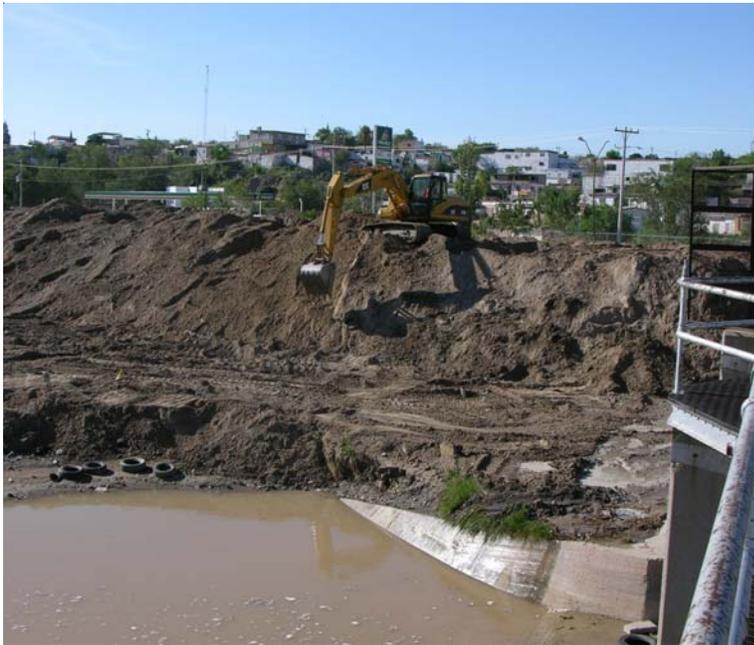
The Commission removed sediment at El Paso-Ciudad Juarez in accordance with Minute 313.

In February, the Commission signed Minute 313, “Maintenance in the Rectified Channel of the Rio Grande.” The agreement makes recommendations for works, such as sediment removal and levee repairs, in critical locations where the Rio Grande channel has problems conveying normal and flood flows as a result of sediment, vegetation growth, and levees in poor condition. The agreement covers a 91-mile (146.4 km) reach of the river from El Paso, Texas-Ciudad Juarez, Chihuahua

downstream to Fort Quitman, Texas. In accordance with the agreement, each country is responsible for removing sediment from specific river reaches totaling 45.5 miles (73.2 km) each. Each country will continue to be responsible for maintaining the floodways and levees on its side of the international boundary. By establishing a clear understanding of the responsibilities to be undertaken by each Section, Minute 313 will facilitate scheduling and funding of maintenance work on an ongoing basis. Failure to perform this work presents a risk of municipal flooding and could result in a change in the river’s course, altering the international boundary.

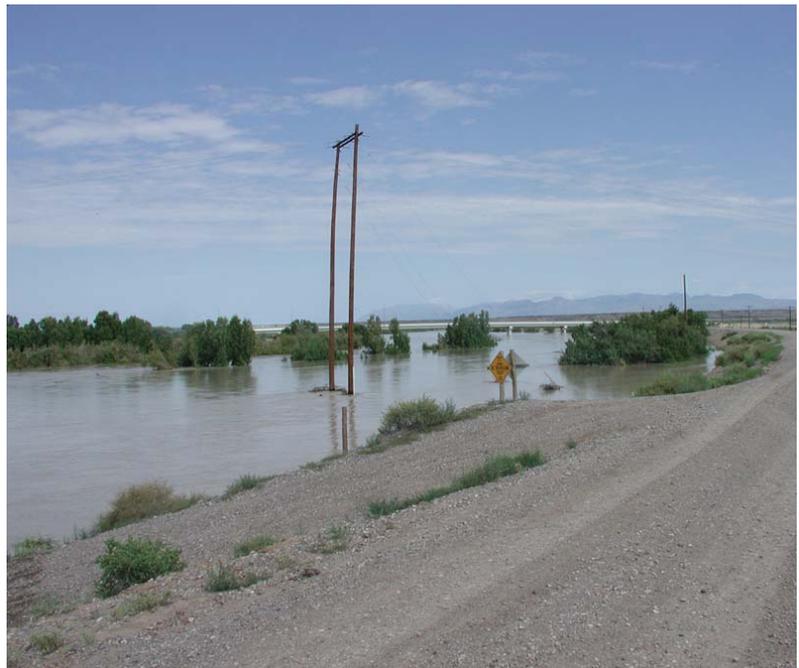
Rio Grande levees near the Presidio-Ojinaga International Bridge were put to the test in both countries.

A segment of the U.S. Rio Grande flood control levee in a rural area downstream of Presidio was overtopped and failed, sending floodwaters onto adjacent farmland and a golf course. Upstream, USIBWC crews worked to shore up the levees protecting the urban part of Presidio, working 24 hours per day to combat seepage and sand boils that put the levees at risk of failure. They also coordinated to have state and local emergency management officials drop large sandbags in a low spot along an existing railroad embankment to prevent floodwaters from the downstream levee break from backing up into town. In Mexico, the failure of levees on the Conchos River and Rio Grande caused major flooding in Ojinaga and forced the closure of the international bridge after the Mexican access road and port facilities were flooded.

USIBWC crews were in active flood fight operations from early September until mid-October, conducting regular levee patrols, using heavy equipment and sandbags to repair levee seepage and sand boils, and pumping floodwaters. The two Sections also coordinated closely regarding flows and dam releases on the Conchos River. Following the flood, both Sections began work on emergency levee repairs and to plan for long-term improvements to the flood control project. As part of the long-term plan, the Commission proposed increasing the capacity of the project to a 100-year design flood rather than the current 25-year capacity.

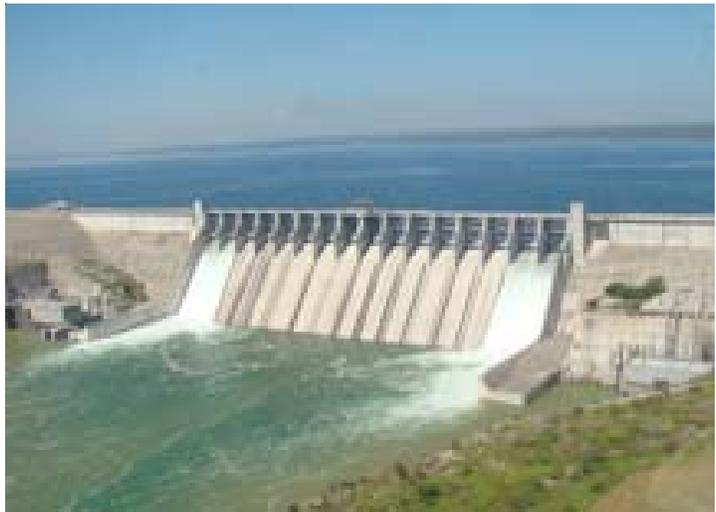
The Commission made flood releases from Amistad Dam in September and October.

At the beginning of September, Amistad Lake was at 1102 feet (335.8 m) elevation with storage at 73% of normal conservation capacity. One month later, the lake had risen 17 feet (5 m) and was just over conservation capacity, its highest level in 15 years. Commission personnel made flood releases from the dam at the rate of 17,657 cubic feet per second (500 cms) for nearly one month before tapering back the third week in October. Historically, releases at this rate have occurred every three to five years but have been less frequent in recent years due to drought.

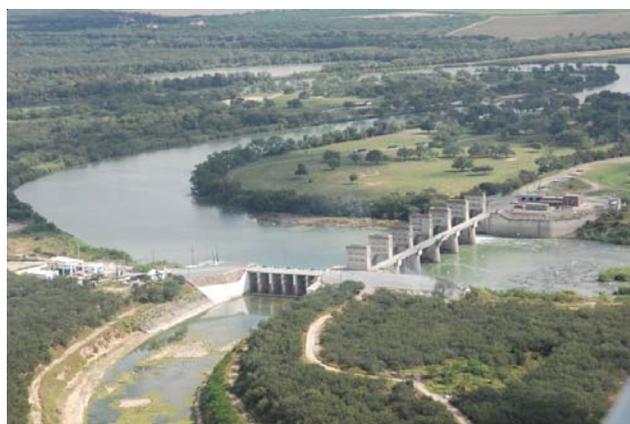
The Commission performed routine maintenance on the gates of Anzalduas Dam.

Construction of a new maintenance shop building on the U.S. side of the dam was completed early in the year. The project included installation of new fencing and pavement in the yard. The Commission also completed annual maintenance on Gates #2 and #5. The work included sand blasting and painting a truss beam and replacing rusted ladders, handrails, and platforms on the gates' marine landing.

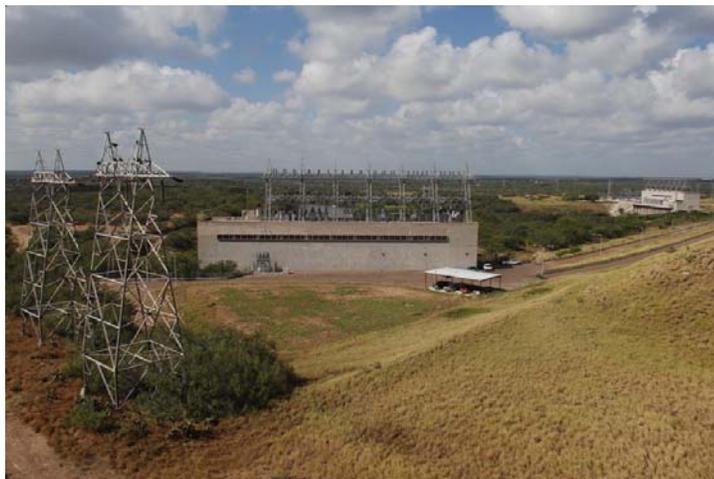
The Commission is considering installing a low-flow generating unit at the Falcon Dam Power Plant.

shut down for 12 to 18 months, and construction of a coffer dam and building expansion would be required. Likewise, at Falcon Dam, conditions at the U.S. Power Plant are much more favorable to installation of the low-flow unit as compared to the Mexican Power Plant. The two Sections are consulting with their respective stakeholders — the Western Area Power Administration and the South Texas Electric Cooperative in the United States and the Federal Electricity Commission and National Water Commission in Mexico — regarding their interest in the proposal.

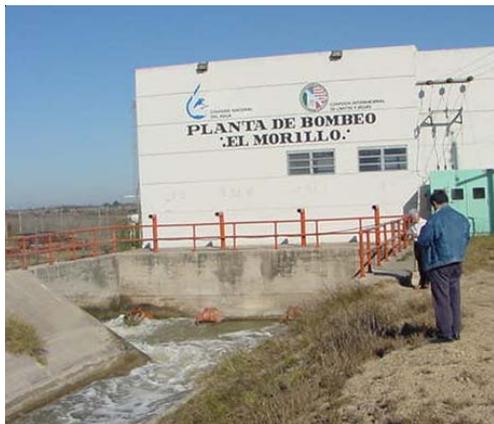
El Morillo Drain pumping plant.

El Morillo Drain is a binational water quality project of the IBWC designed for salinity control purposes. Extending for 75 miles (121 km) through Tamaulipas, the drain diverts saline irrigation return flows to the Gulf of Mexico, preventing degradation of Rio Grande water quality. El Morillo Drain

experienced various operational difficulties, including pumps that were not functioning, accumulation of silt and trash in the Drain, and challenges related to flood management in Mexico. During the summer, saline water overflowed into the Rio Grande for an extended period of time; however, the salinity level did not pose a concern to Texas irrigators or the Texas Commission on Environmental Quality. When Morillo Drain water flows into the Rio Grande instead of being diverted to the canal, it is usually within acceptable salinity levels.

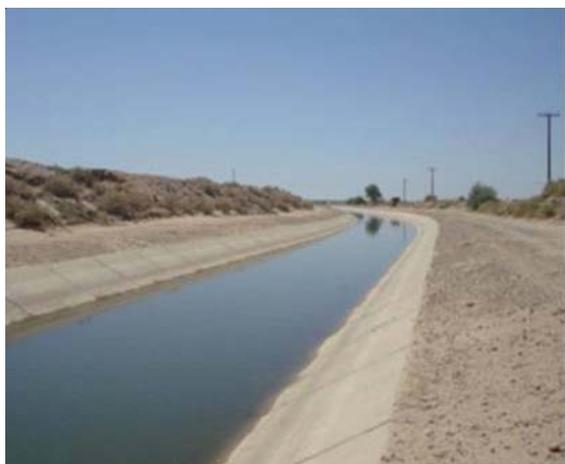
The Wellton-Mohawk Drain after sediment was removed.

The Wellton-Mohawk Drain bypasses saline irrigation return flows from the United States to improve the quality of Colorado River water delivered to Mexico. In accordance with Minute 284, the United States pays for maintenance for a portion of the drain in Mexico. In June, a break in the drain was detected, which caused water to flow across the desert. Due to a sediment plug downstream in the area maintained by Mexico, the water had backed up and saturated the canal, causing it to break. The U.S. Bureau of Reclamation funded repair work, which included repair of the canal and removal of sediment. Both Sections worked together on the development of a contract to accomplish the repairs.

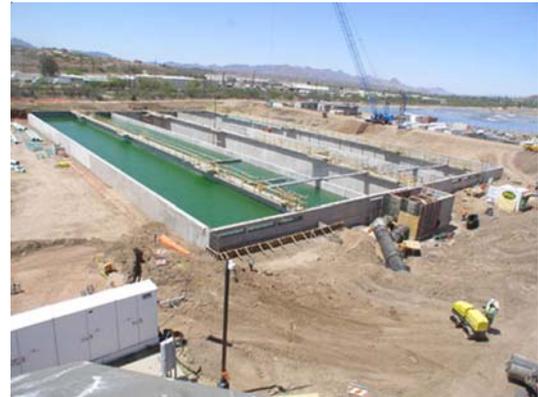
Construction of the NIWTP upgrade.

Located in Rio Rico, Arizona, the Nogales International Wastewater Treatment Plant (NIWTP) was constructed in 1972 within the framework of IBWC Minute 227 to treat wastewater from the sister cities of Nogales, Arizona and Nogales, Sonora. Minute 276, signed in 1988, provided for the expansion of the NIWTP and allotted to Mexico 9.9 million gallons per day (mgd) (434 liters per second) in treatment capacity at the plant.

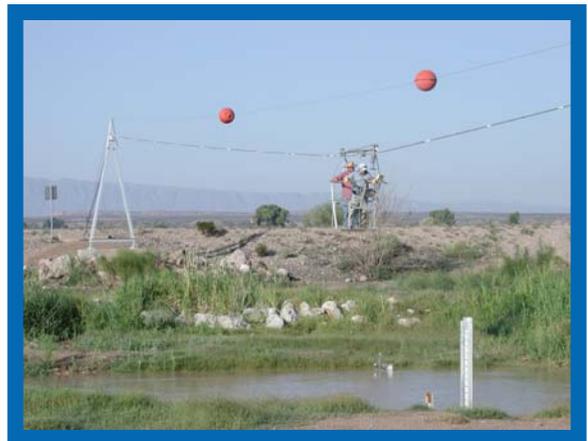
Staff takes a manual measurement of Rio Grande flow.

The Rio Grande flood destroyed the instruments of the El Mulato gaging station downstream from Presidio, Texas-Ojinaga, Chihuahua; the Commission plans to move the station to a new site. A new flood gaging station at the Cordova International-Bridge of the Americas at El Paso, Texas-Ciudad Juarez, Chihuahua was fabricated and installed. Work was initiated to purchase a replacement for the 11-mile gage on the Colorado River, which was vandalized in September. Routine maintenance and inspections of the other gaging stations were carried out.

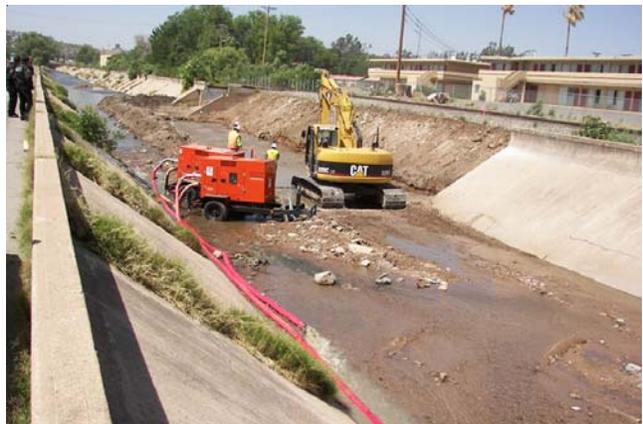
Repairs were made to the Nogales Wash before the rainy season.

The U.S. Section repaired a segment of the Nogales Wash channel in the United States that was damaged during a storm in August 2007. The Nogales Wash is a concrete-lined channel that flows north from Nogales, Sonora to Nogales, Arizona. The storm damaged a 150-foot long (46 meter) segment, washing out the floor of the channel and leaving a void behind a portion of the channel wall in a section located 1.5 miles (2.4 km) north of the U.S.-Mexico border. The \$500,000 repair was carried out in May and June. Repairs were considered critical in order to protect the International Outfall Interceptor (IOI). Located in the damaged section of the wash, the IOI conveys wastewater from the international boundary to the Nogales International Wastewater Treatment Plant. Had the pipe ruptured, it could have released untreated wastewater into the wash, creating a potential public health threat.

The repairs from the 2007 storm were completed just prior to the 2008 monsoon. Unfortunately, the summer rainy season brought additional problems for the Nogales Wash and caused widespread flooding in both countries. A July 6 storm dislodged a concrete floor panel from the Nogales Wash just north of the area damaged the previous year. The U.S. Section assisted the City of Nogales, Arizona with repair, part of an effort to protect the IOI and to prevent the panel from getting swept downstream and causing additional damage.

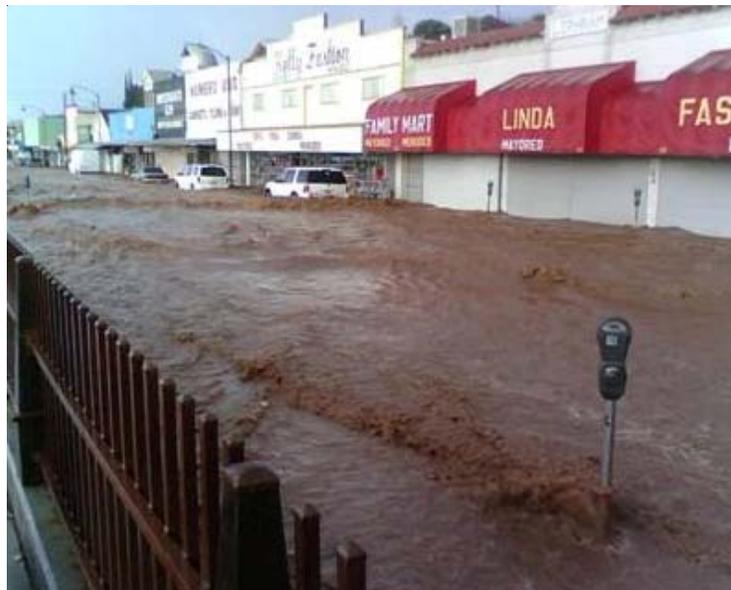
Flood in Nogales, Sonora that caused the collapse of part of the Nogales Wash tunnel.

Just days later, on July 12, another summer downpour led to major flooding in downtown Nogales, Arizona and Nogales, Sonora, causing a part of the Nogales Wash tunnel in Mexico to collapse and inundating businesses on both sides of the border. Subsequent studies by Commission engineers determined that a U.S. Border Patrol wall and a large Mexican sewage pipe in the tunnel created obstructions to stormwater flowing through the wash, contributing to the flooding. The storm also dislodged two panels in the open channel portion of the wash in the United States; the City of Nogales, Arizona repaired the damage.
