San Pedro Targeted Watershed *E. coli* Reduction Project

San Pedro River Targeted Watershed: AGWA Delineated Watersheds

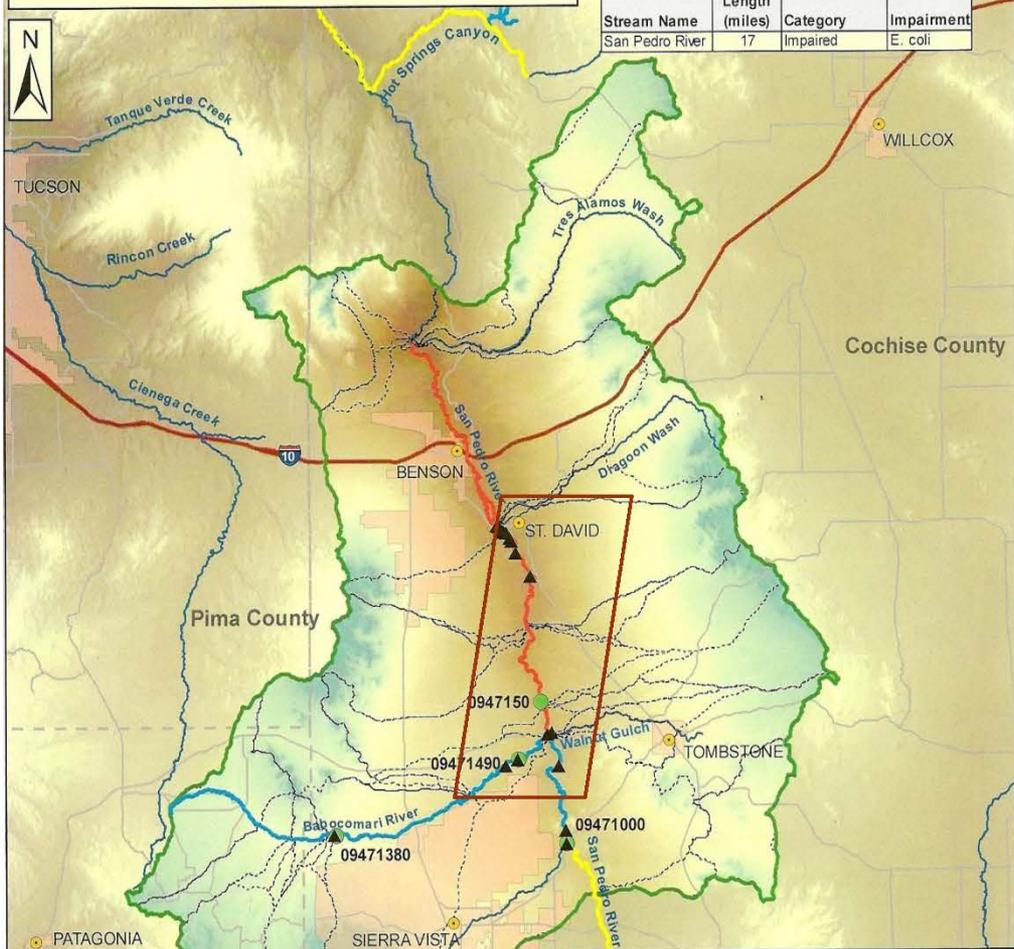
Stream Name	Length (miles)	Category	Impairment
San Pedro River	17	Impaired	E. coli

*Area of interest is the impairment on the San Pedro River between the Baboquivari River and Driagoon Wash.
