PdNWC Watershed Restoration Planning Project for the El Paso-Las Cruces Watershed

Rio Grande Citizen's Forum

January 16, 2013

Chris Canavan, NMED

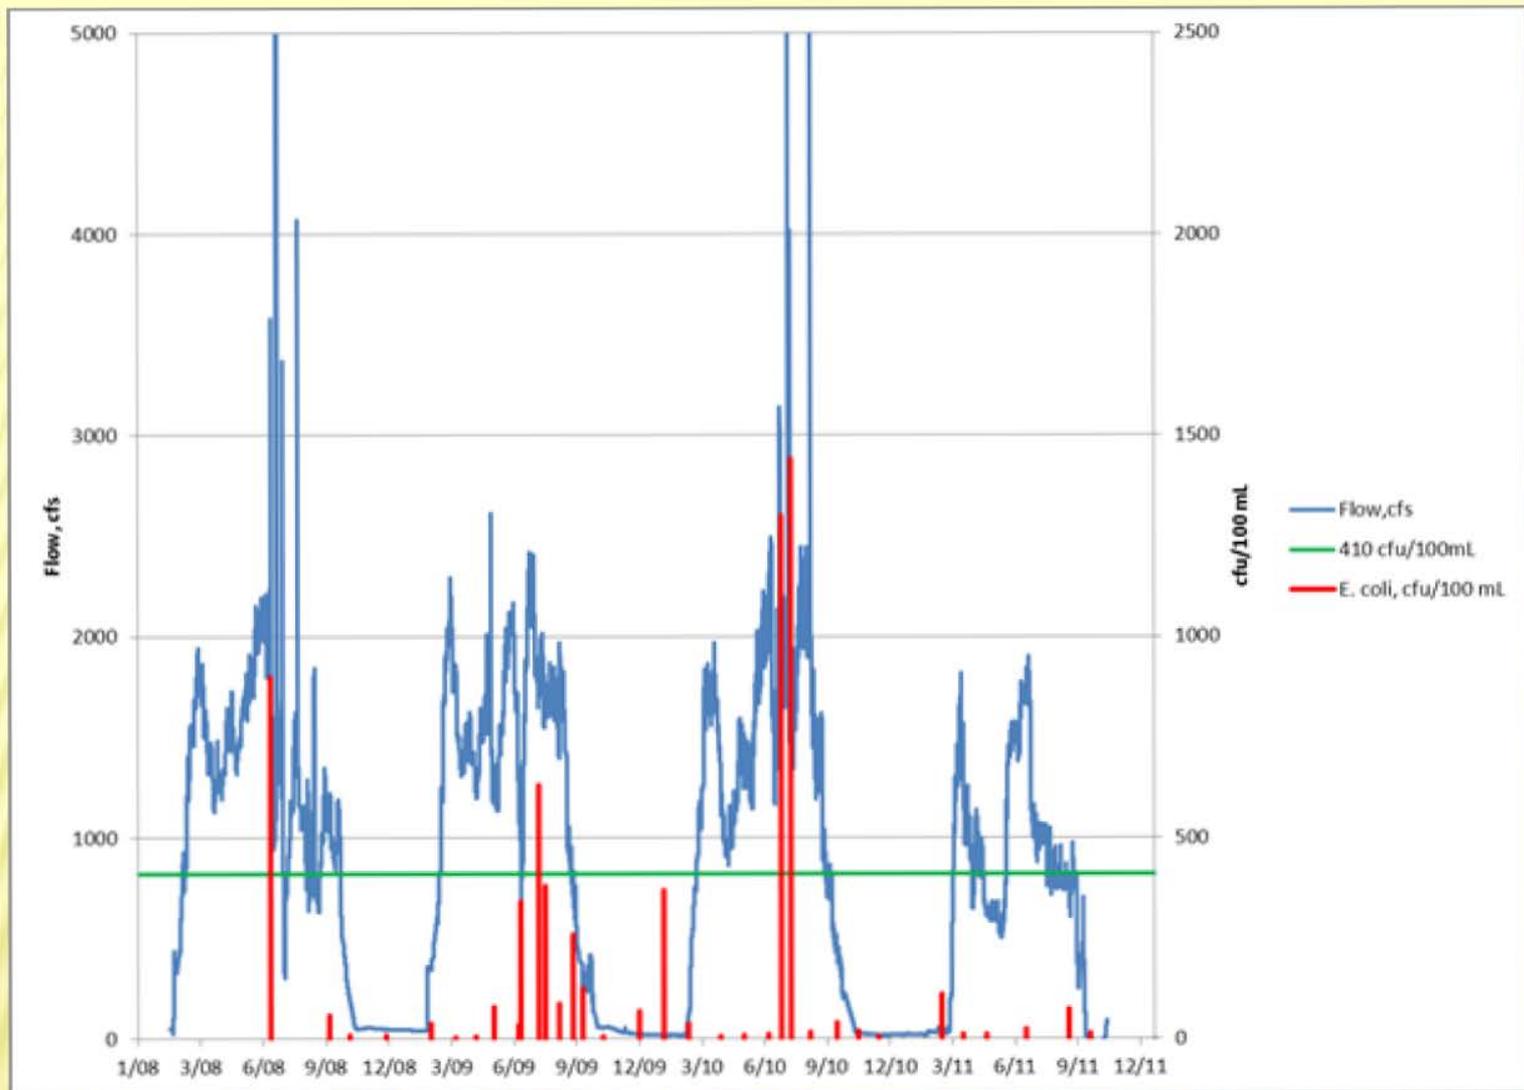
Flow and routine *E. coli* sampling results for the Rio Grande at Hayner Bridge.

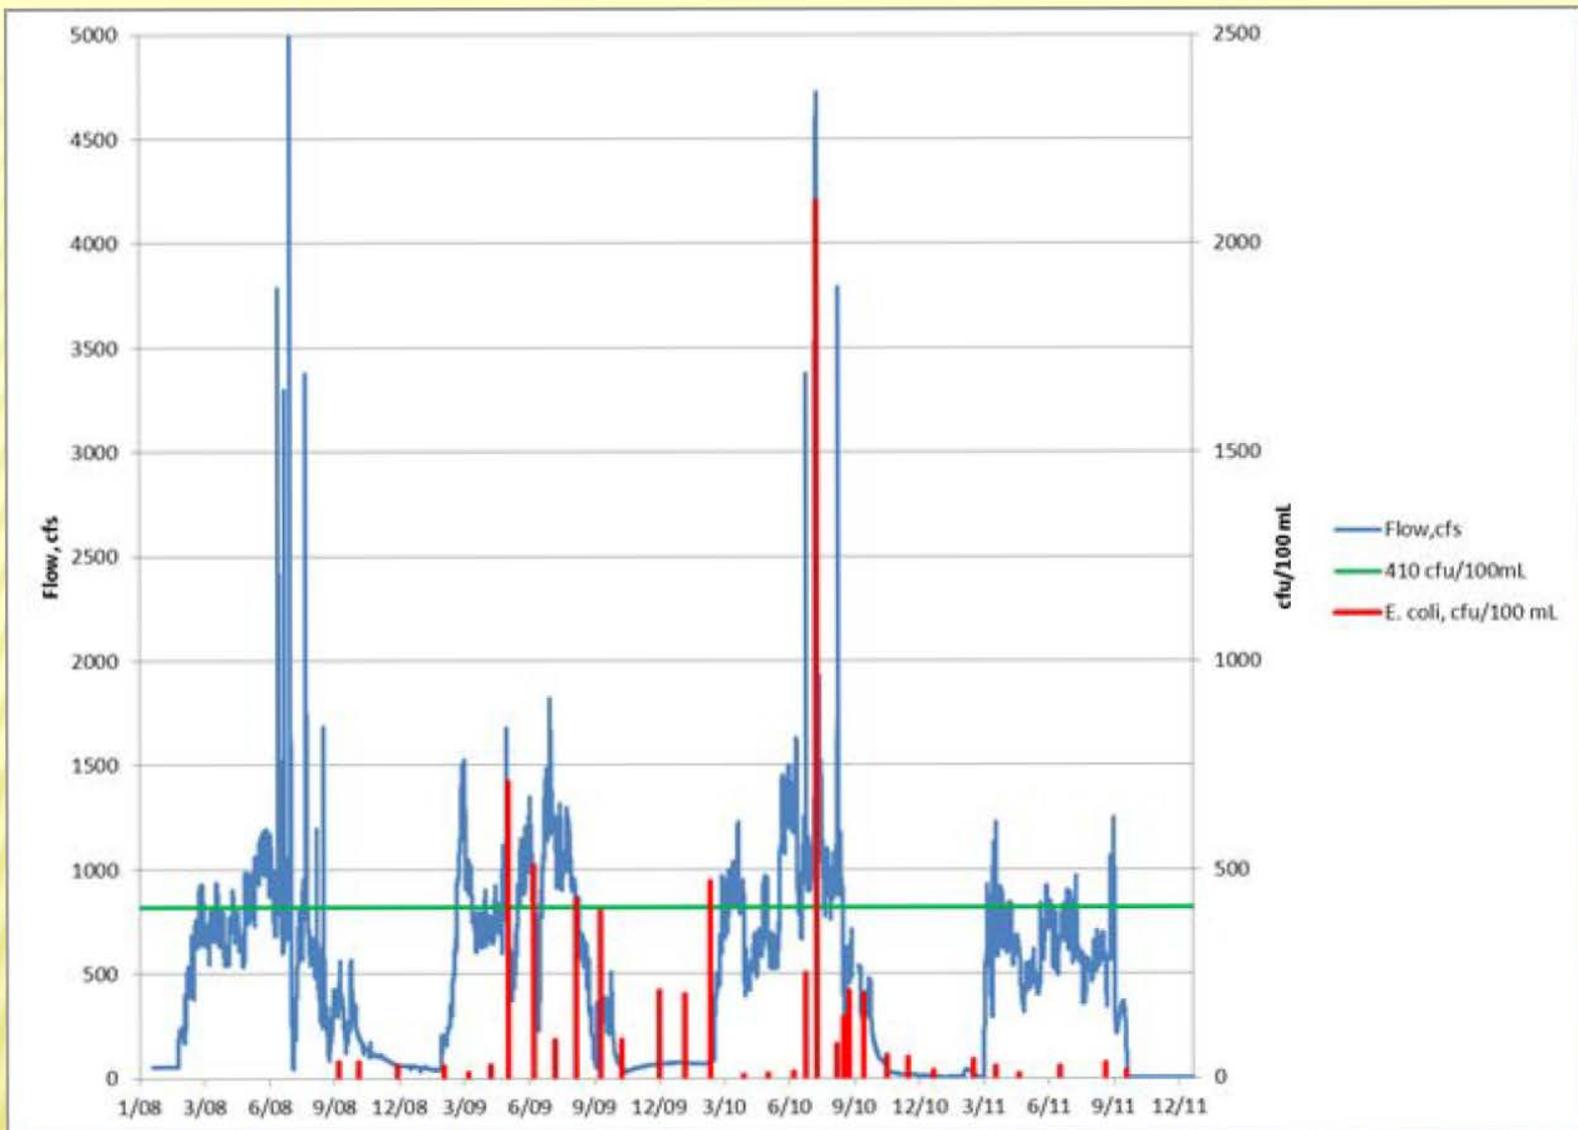
Flow and results of routine *E. coli* sampling at the Rio Grande at Anthony Bridge.

Anthony Bridge sampling revealed a pattern of elevated *E. coli* concentrations unrelated to stormwater runoff.

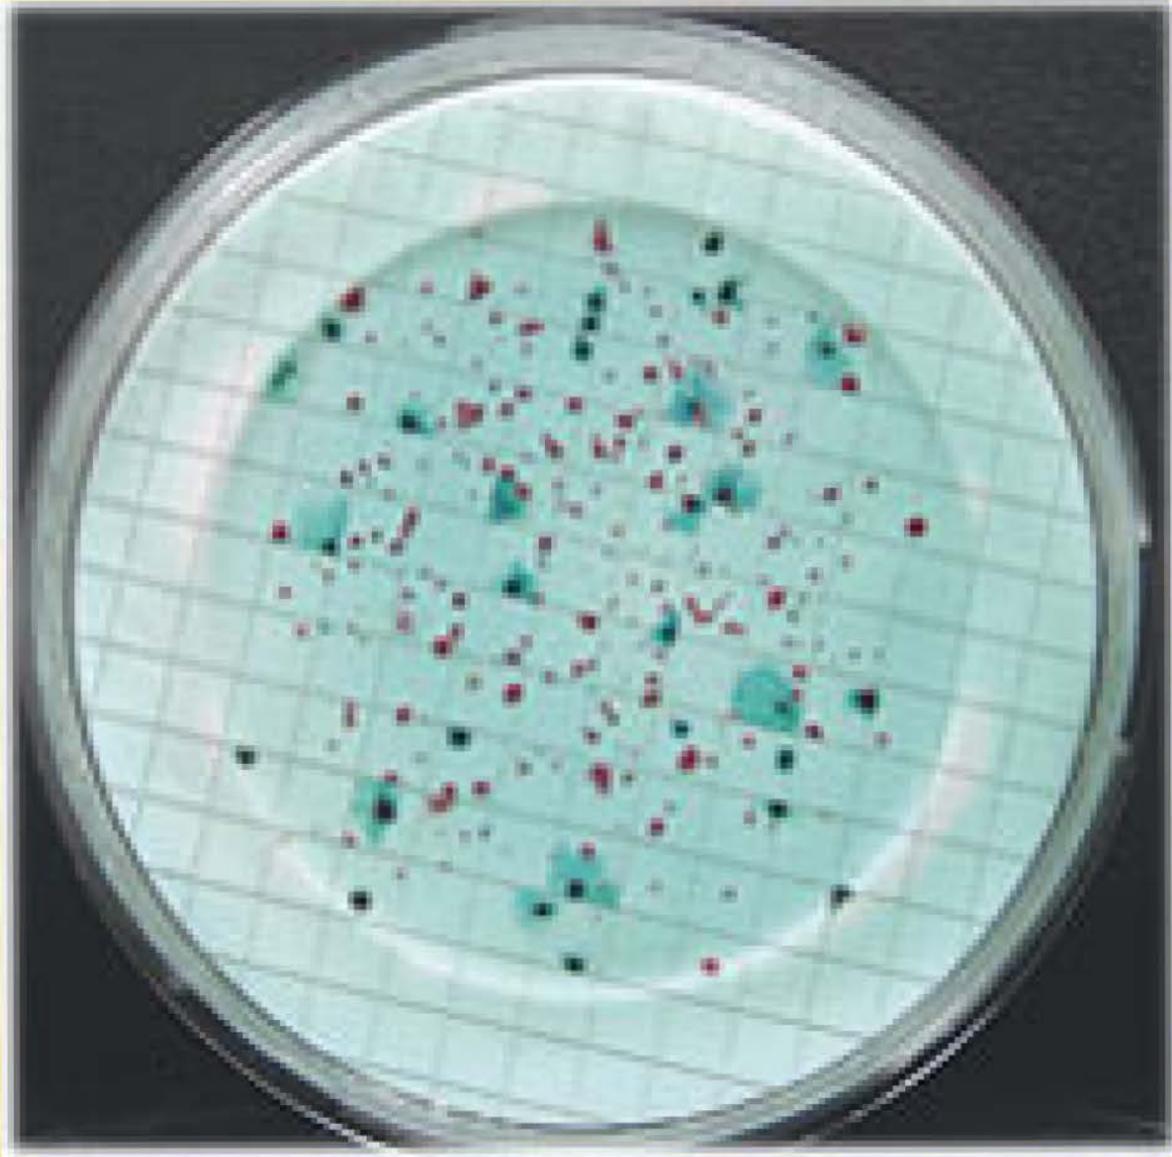
M-Coliblu24 plate.

- Triplicate samples were collected.
 - Samples were analyzed with the m-Colibblue 24 method.
 - Filters were held for up to 5 days then shipped to lab.
 - *E. coli* DNA is then extracted using Pulsed Field Gel Electrophoresis.
 - Results are then compared with genetic library reference DNA.
-

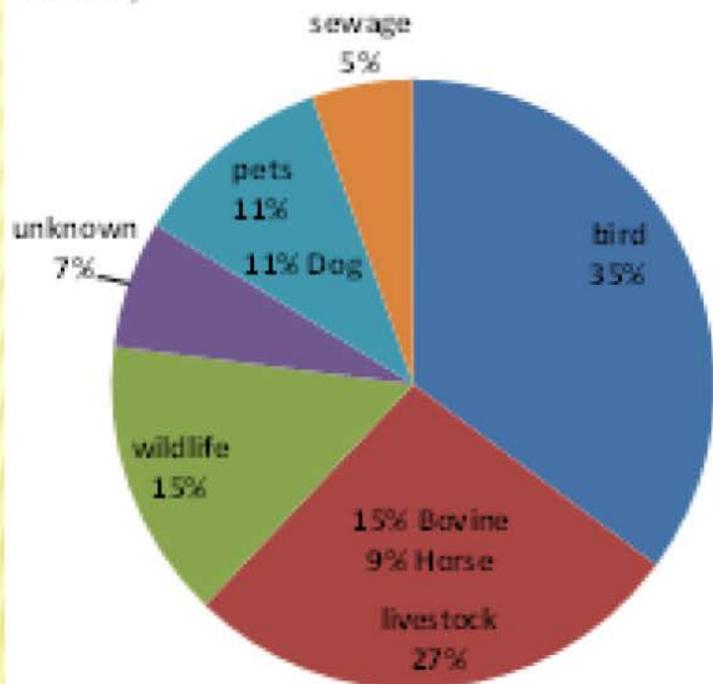
RioGrande
Anthony

Anthony, n= 74	%
bird	35.1
livestock	27.0
wildlife	14.9
unknown	6.8
pets	10.8
sewage	5.4

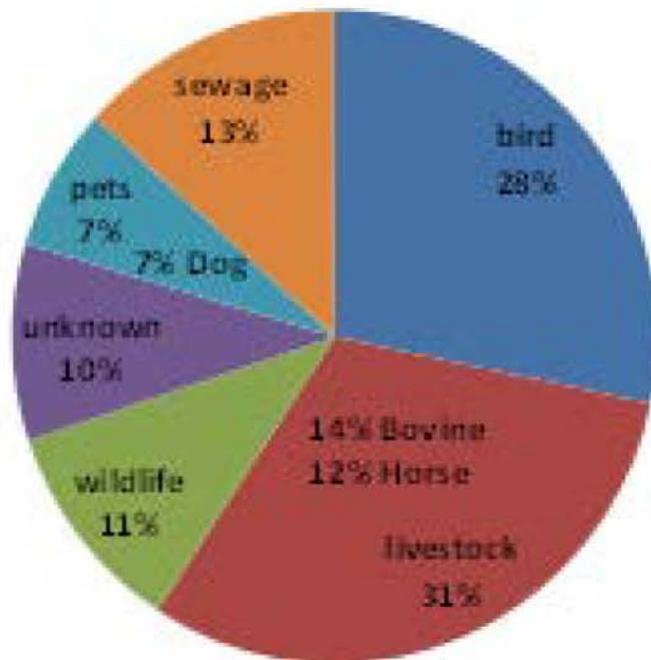
East Drain

East Drain, n = 113 %

bird	28.3
livestock	31.0
wildlife	10.6
unknown	9.7
pets	7.1
sewage	13.3
